Flood Investigation Section 19 Report

BL000021/RP/01 | 02

01 November 2021

London Borough of Havering

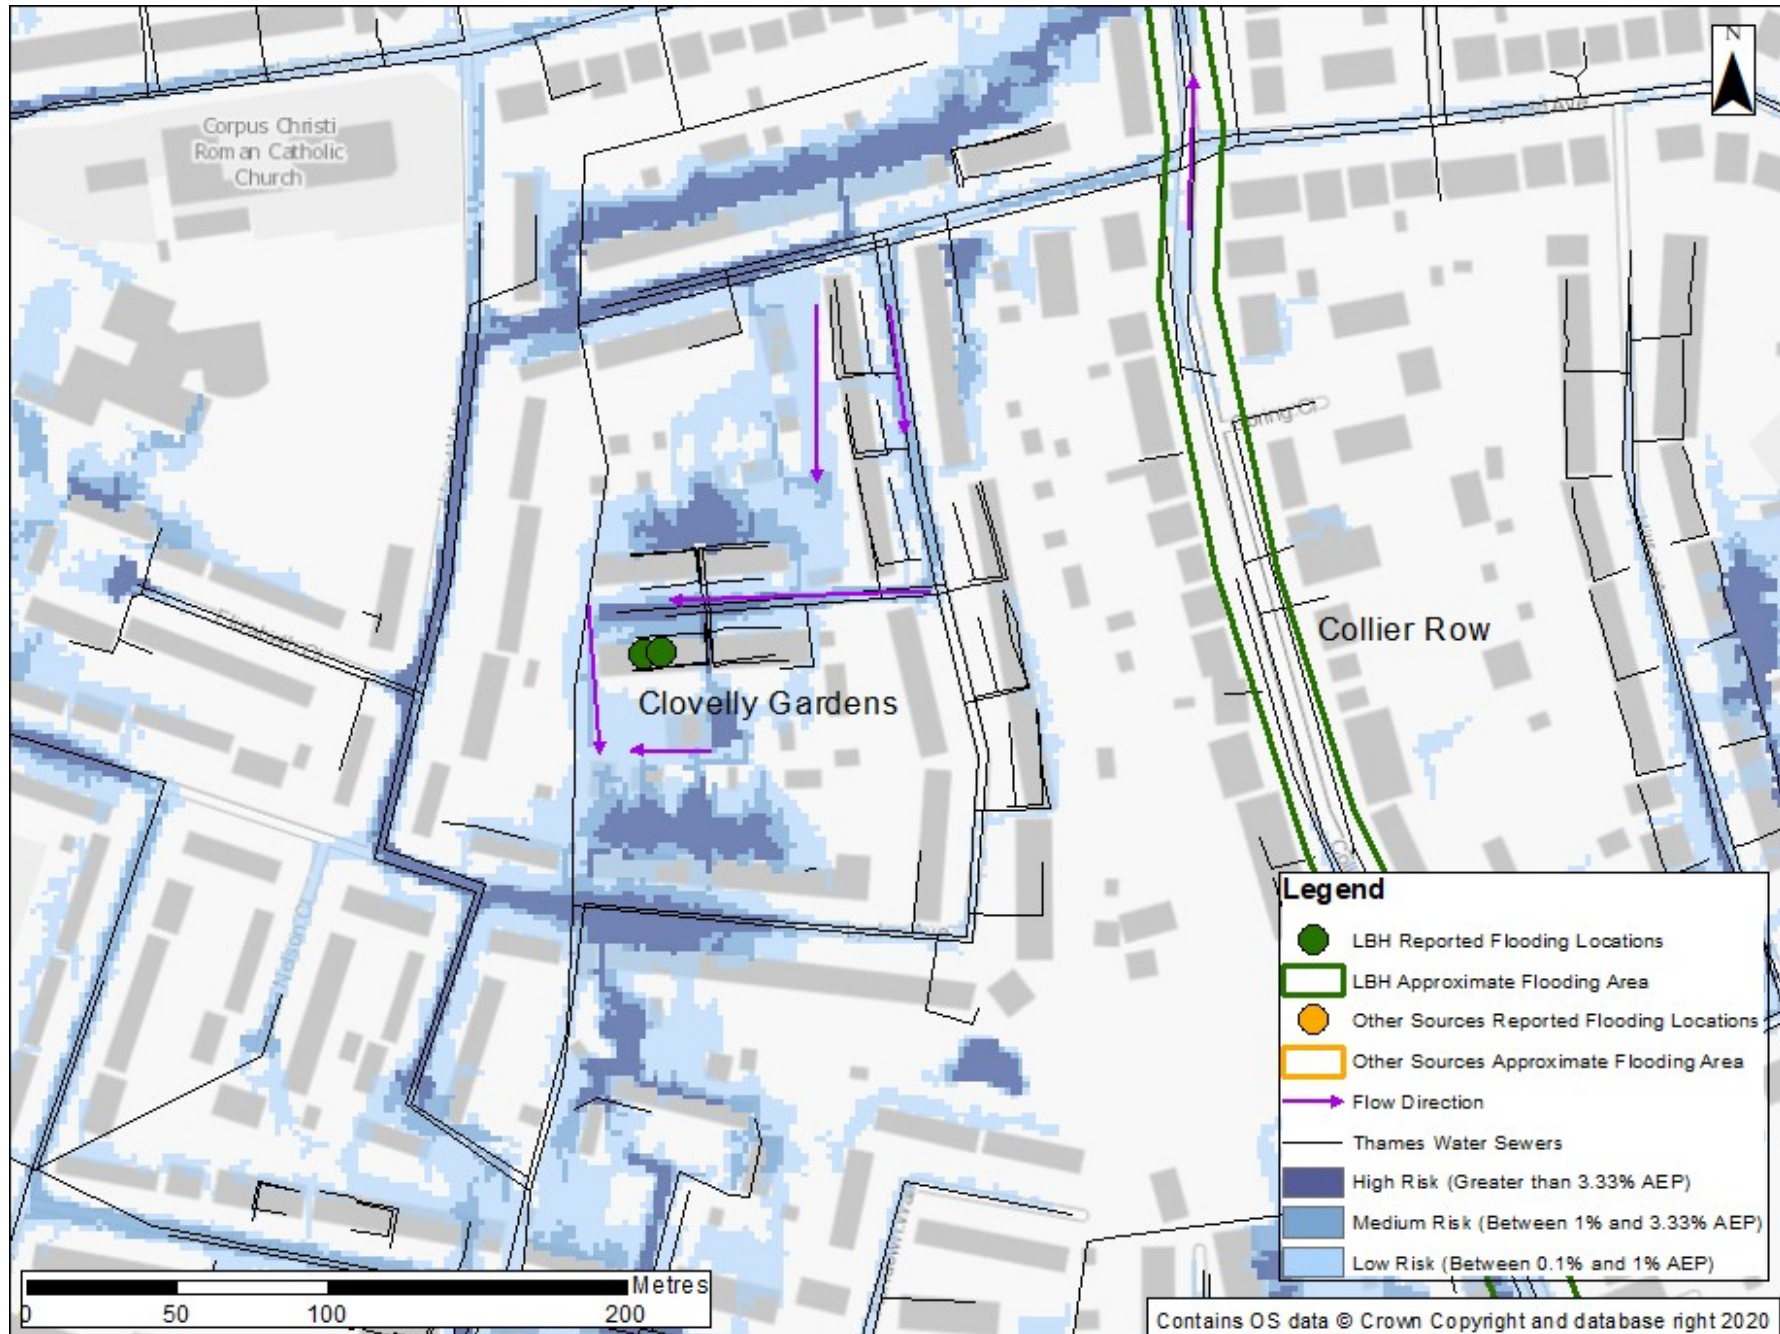
A.1 Clovelly Gardens

Location	Observed flood extent	Environment Agency RoFSW extent	Comparison
1. Clovelly Gardens	<p>Reported flooding along Collier Row - no specific location given.</p> <p>LBH also reported two property flooding along Clovelly Gardens.</p>	<p>There is low risk of surface water flooding along Collier Row Lane.</p> <p>Affected properties along Clovelly Gardens are outside the surface water flood extent however, the carriageway directly in front of the properties is shown to be at a high risk of surface water flooding.</p>	<p>The affected properties are within an approximate 20m radius of the RoFSW mapping extents.</p> <p>This includes a surface water flow path along Clovelly Gardens.</p>

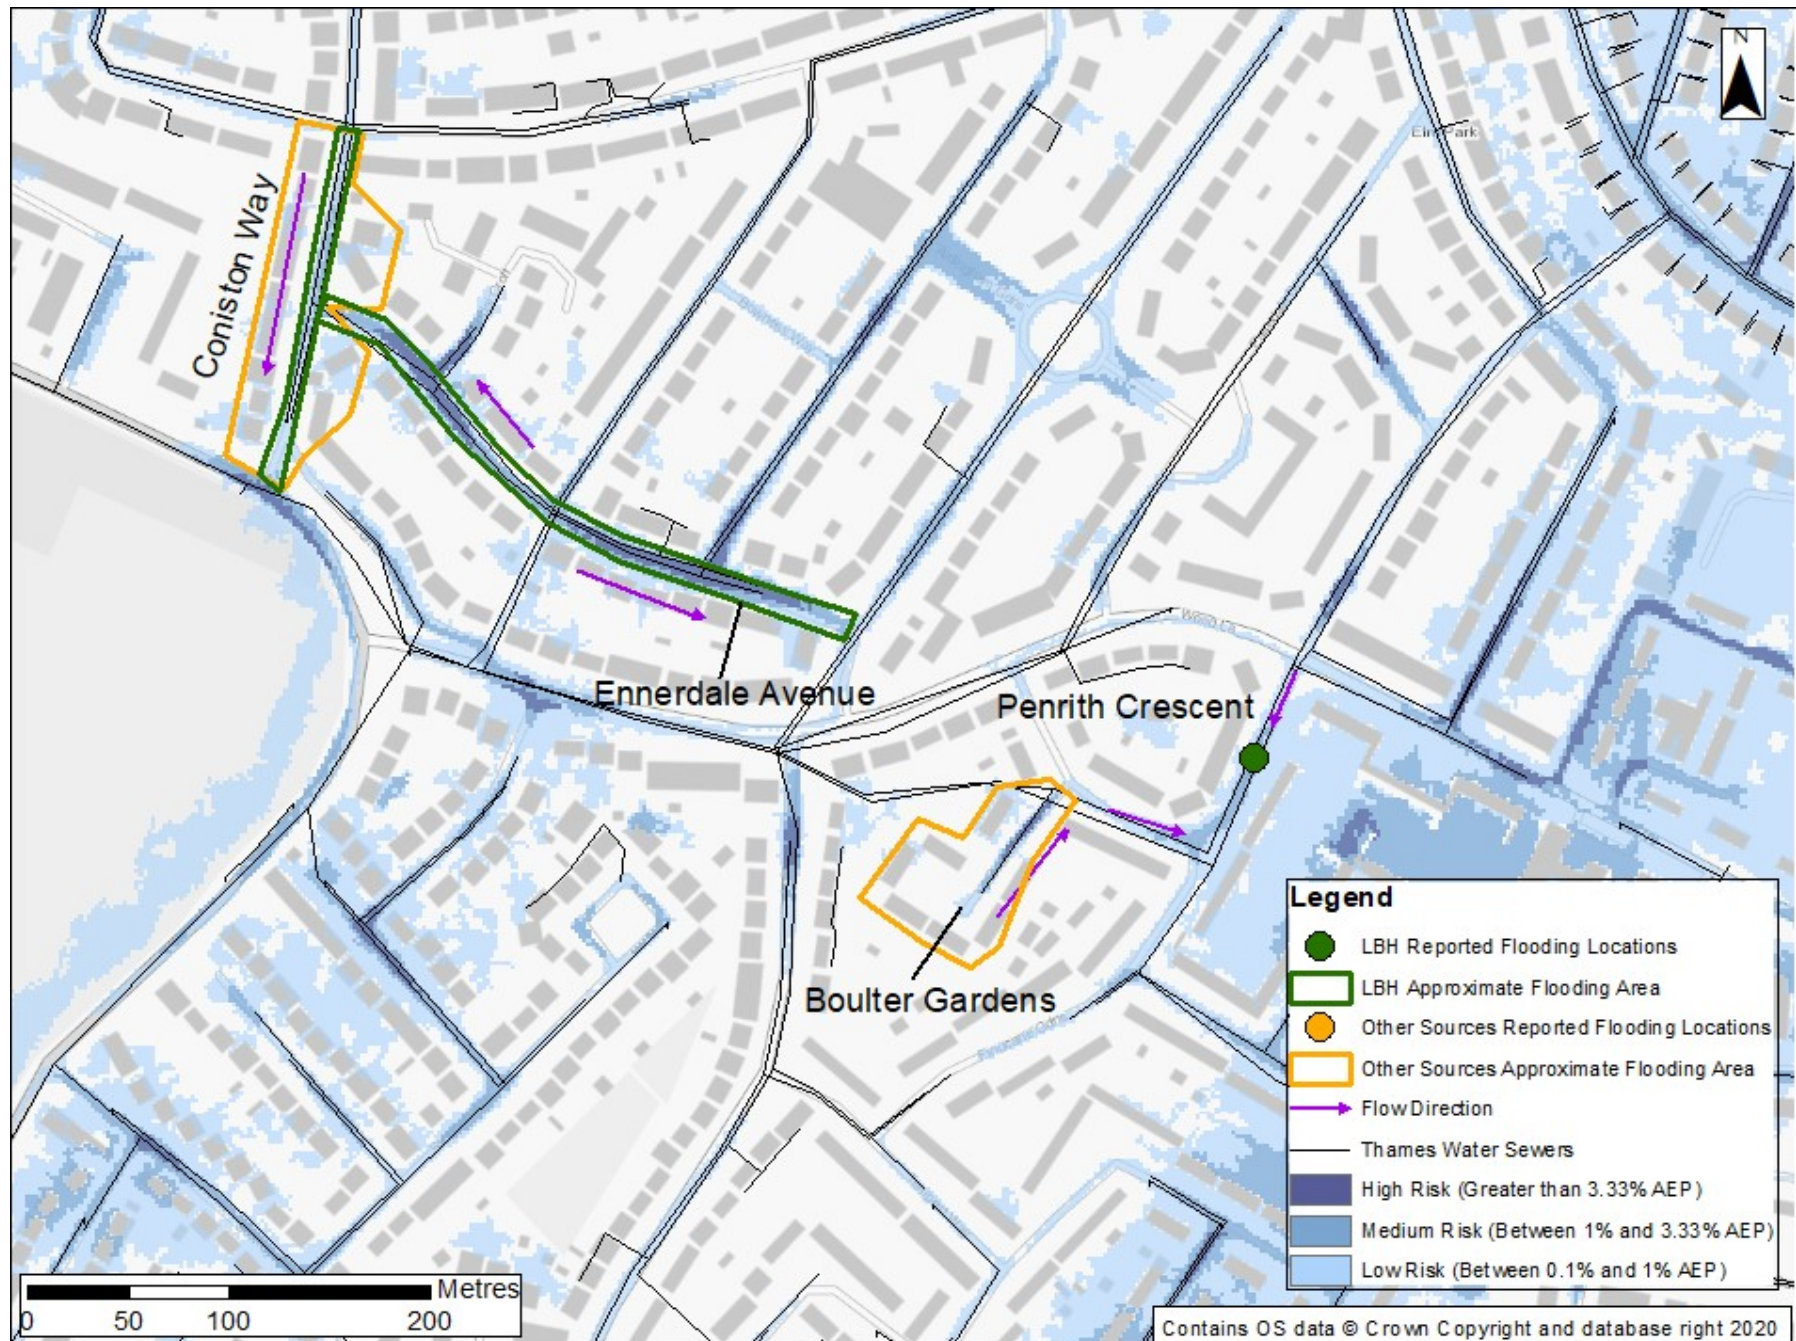
A.2 Elm Park and Penrith Close

3. Penrith Crescent	<p>Carriageway flooding reported in front of one property along Penrith Crescent and flooding at nearby Boulter Gardens (unknown type/location).</p>	<p>Low to medium surface water flood risk at reported location of carriageway flooding along Penrith Crescent and low to high along Boulter Gardens carriageway.</p> <p>It is unclear if any properties were affected by flooding at Boulter Gardens, the RoFSW mapping indicates none are at risk.</p>	<p>Good agreement between the observed carriageway and RoFSW mapping.</p>

2. Elm Park	<ul style="list-style-type: none"> • Carriageway at the junction of Conistan Way and Ennerdale Avenue is at topographical low point. It is unknown where along the carriageway of both roads flooding was observed. • Properties are slightly elevated above road level. One report does not specify flooding type/specific location.

3. Penrith Crescent	<ul style="list-style-type: none"> • Topography observed to fall along Penrith Crescent towards Boulter Gardens (LFB caller location), away from the reported location of carriageway flooding along Penrith Crescent • One report does not specify flooding type/ specific location.

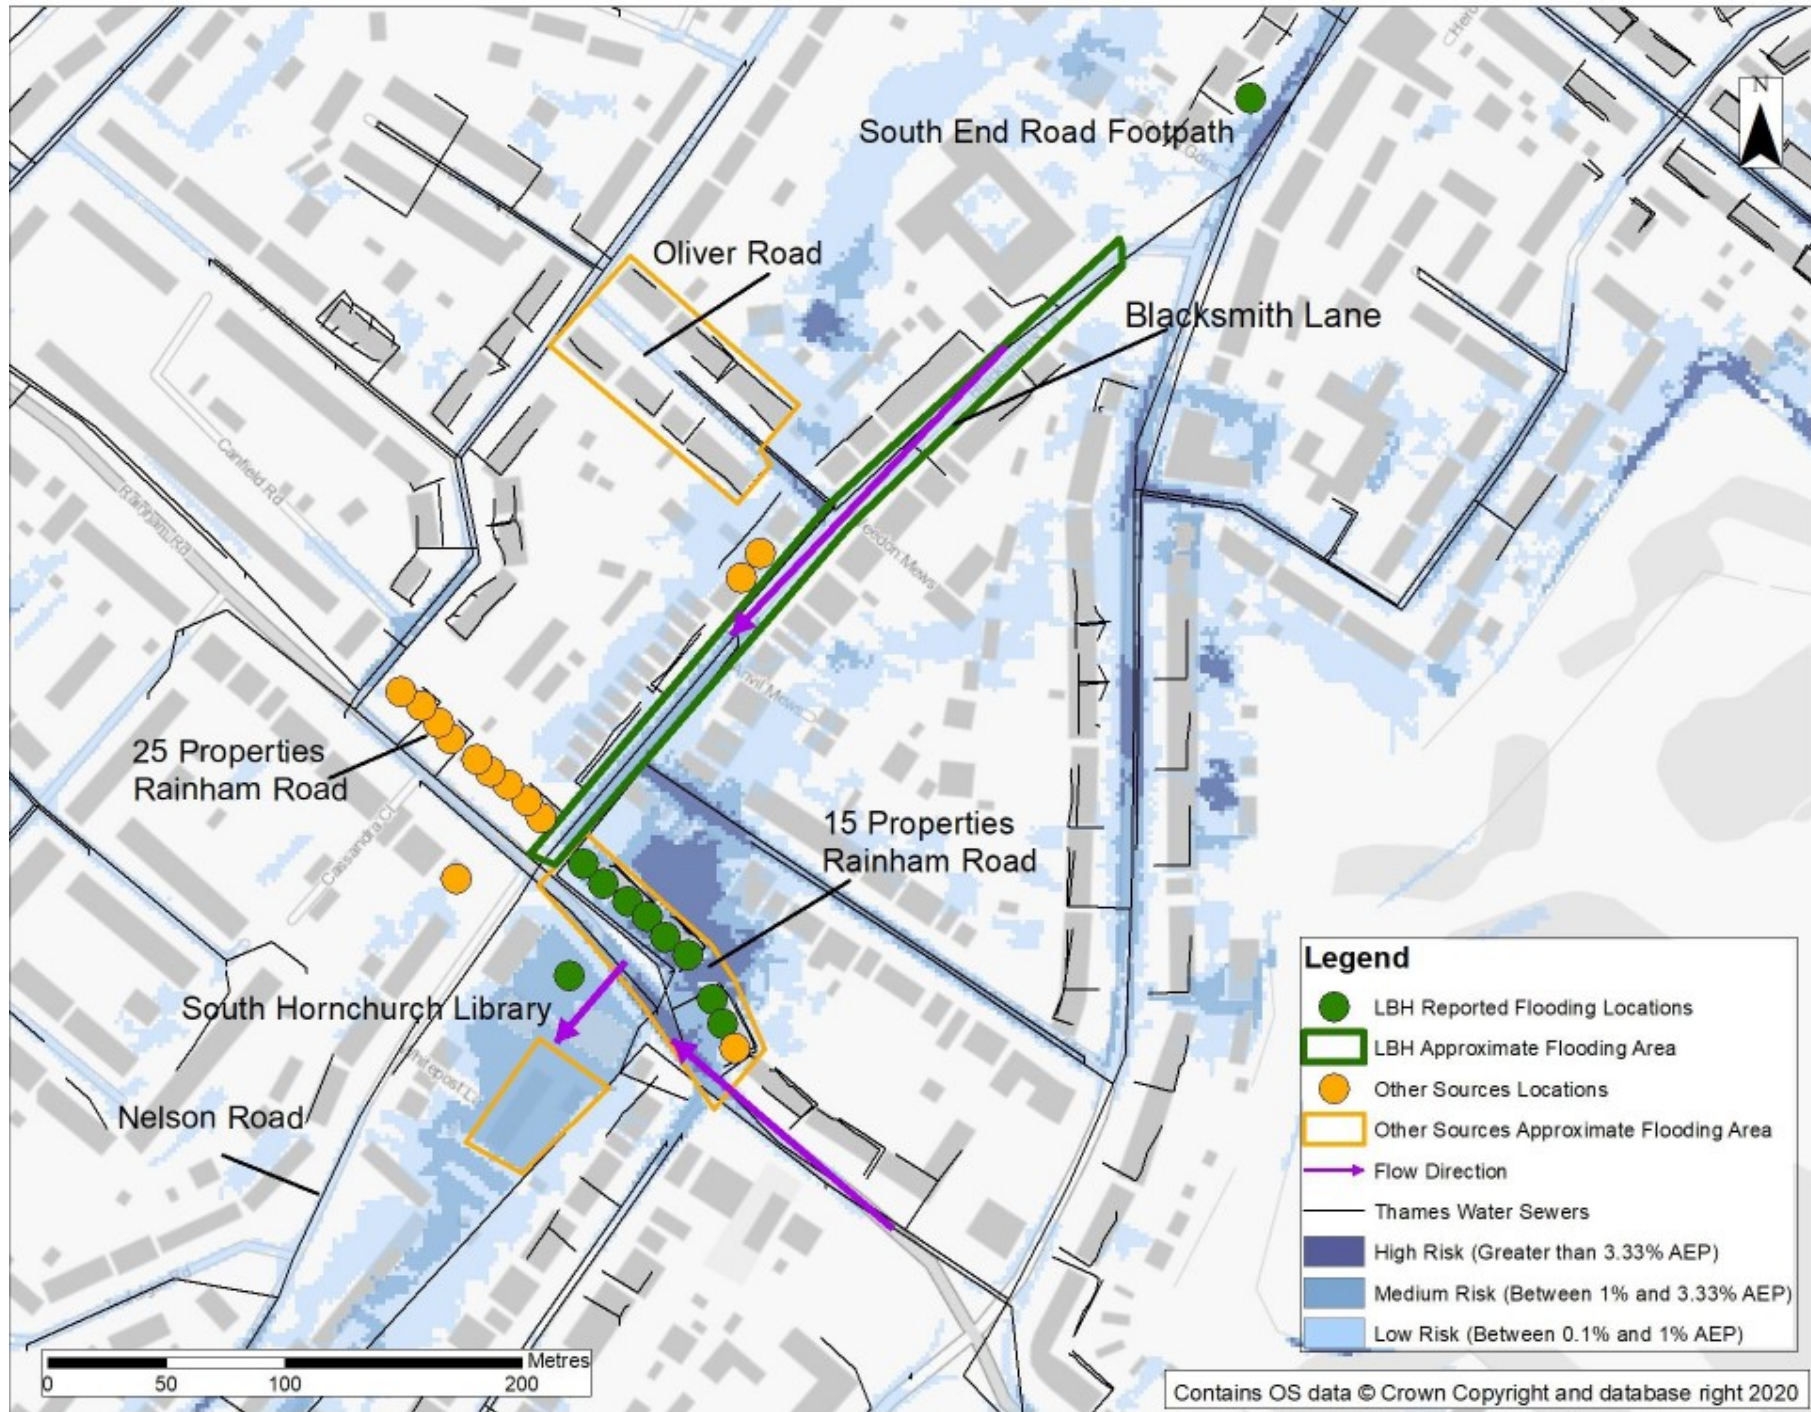
A.3 Blacksmith Lane & Rainham Road

4. Blacksmith Lane & Rainham Road	<ul style="list-style-type: none"> • Observed ground levels support possibility of a flow path along Blacksmith Lane (north-east to south-west), in line with reported carriageway flooding. However, the topographical low point was observed to be before the intersection with Rainham Road (A125) where the Police reported flooding . • Camber of Blacksmiths Lane suggests reported flooding location from TW was more likely to be the other side of the road from reported location or to rear of properties. Properties along Blacksmiths Lane elevated slightly above road level. • Properties along Blacksmiths Lane have airbricks at low levels in the walls.

<ul style="list-style-type: none"> • Building and property associated with South Hornchurch Library land with significantly lower ground levels than surrounding area and adjacent Rainham Road. This aligns with recorded standing water observed around the Library. • Observed ground levels support flow path along Rainham Road, with a slight fall towards the south-west and the junction with Nelson Road. Flooding reported on both north side of Rainham Road, both sides of the junction with Nelson Road. • Properties which reported flooding along Rainham Road (east) have airbricks at low levels in the walls. • Thame Water asset observed centre of Oliver Road, aligns with locations for manholes within the TW asset data.
<p>5. Nelson Road, Spinney Close and Betterton Road</p>	<ul style="list-style-type: none"> • Observed ground levels support flow path along Nelson Road, from north-east to south-west. Difficult to distinguish on site if ground levels continue to fall in this direction across residential properties towards Betterton Road as suggested by LiDAR. • Localised topographical low point observed along Nelson Road where properties reported flooding. The 6 properties reporting internal flooding did not appear raised above road level. No significant impediment observed from the road to the properties. • Several gullies observed both sides of Nelson Road. However, general camber of the road supports the reported location of the flooded properties. • Another local topographical low point observed along Stanley Road, near the intersection with Nelson Road. Location supports the reported flooding locations from TW and the LFB. • Aco Drains were located around the point in which ground levels of Spinney Close were observed to fall towards internally flooded properties. Aco Drains also observed at the edge of the properties/driveways. • Observed ground levels suggest potential for flow path along Betterton Road, from north to south, not shown in the surface water flood risk mapping. The specific location of flooding reported along Betterton Road is unknown.

One example of poor agreement between observed and EA flood mapping is at location 4: Blacksmith Lane and Rainham Road (Figure A3, Appendix A). There is the potential that the surface water flood risk mapping underestimates the extent of flooding. The fact that localised flooding was recorded outside of the predicted RoFSW mapping extents, suggests that the August event could potentially have been a greater than a 3.33% (1 in 30) AEP event, at least in localised areas. Again, sewer capacity and/or condition could be a contributing factor to the flooding observed outside of the RoFSW mapping extents. However, there is insufficient evidence to definitively conclude that this is the case for the locations for which the mapping had poor agreement with the observed flooding locations and there may be other underlying causes that have not been identified.

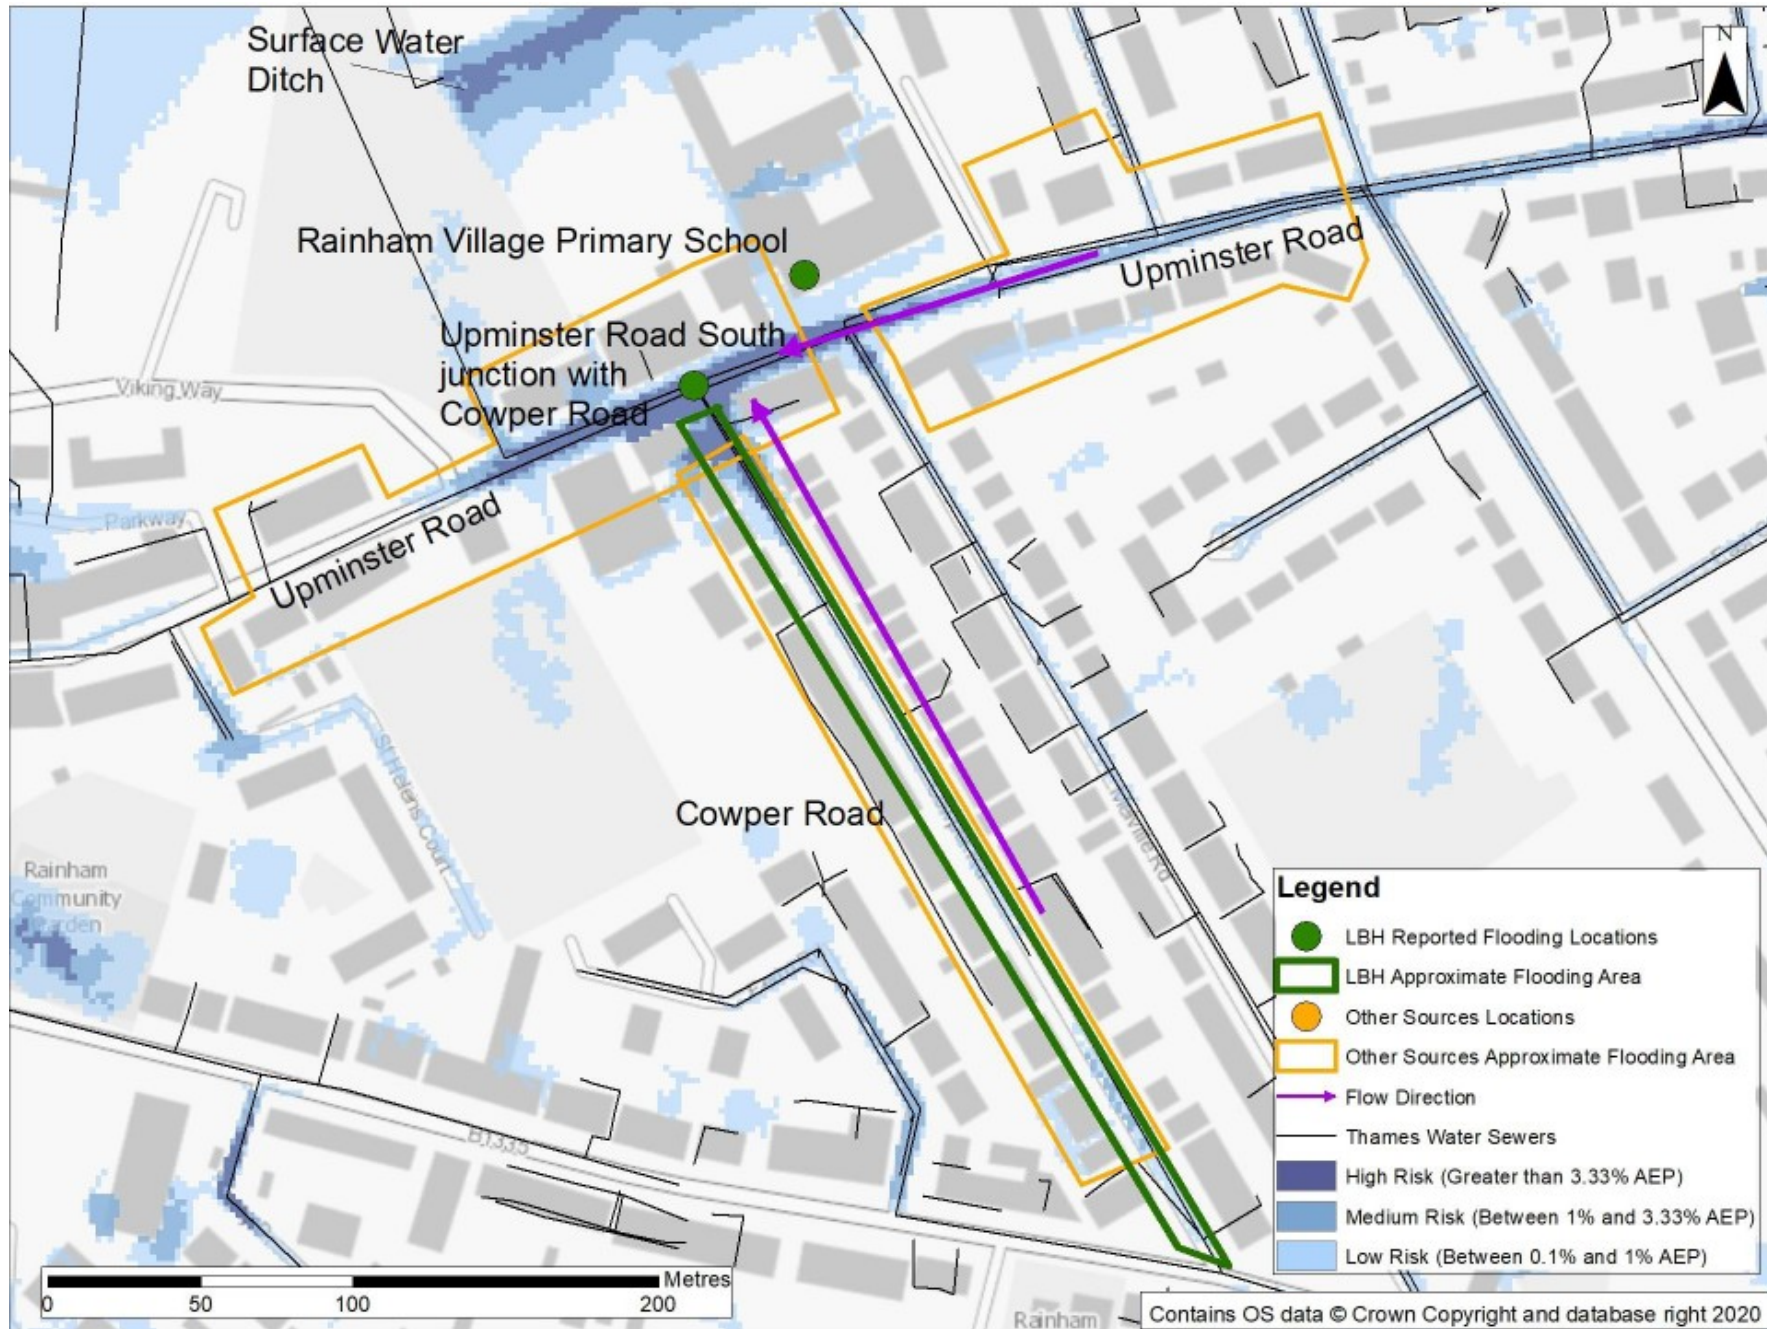
A.9 Upminster Road

10. Upminster Road	<ul style="list-style-type: none"> Ground levels along Upminster Road predominantly fall from north-east to south-west. Topographical low point observed at the junction of Upminster Road and Cowper Road (topography of Cowper Road observed gradual fall north-east to junction). This corresponds with reports of flooding at the junction (carriageway and unknown property location). Observed ground levels support flow path along Upminster Road. However, unclear how flood waters could have entered the Rainham Village Primary School from that point (internal flooding reported). Potential entry point to the property near the corner of Cowper Road and topographical low point, where school property is not surrounded by brick wall. To the north-east along from this point, along the property boundary school is separated from the road by a short brick wall. Observed what appeared to be a relatively new full width speed hump at the bottom of Cowper Road (at the junction with Upminster Road) with signs of resurfacing in the area. One report of flooding along Cowper Road does not specify flooding type/ location, one specifies carriageway flooding.

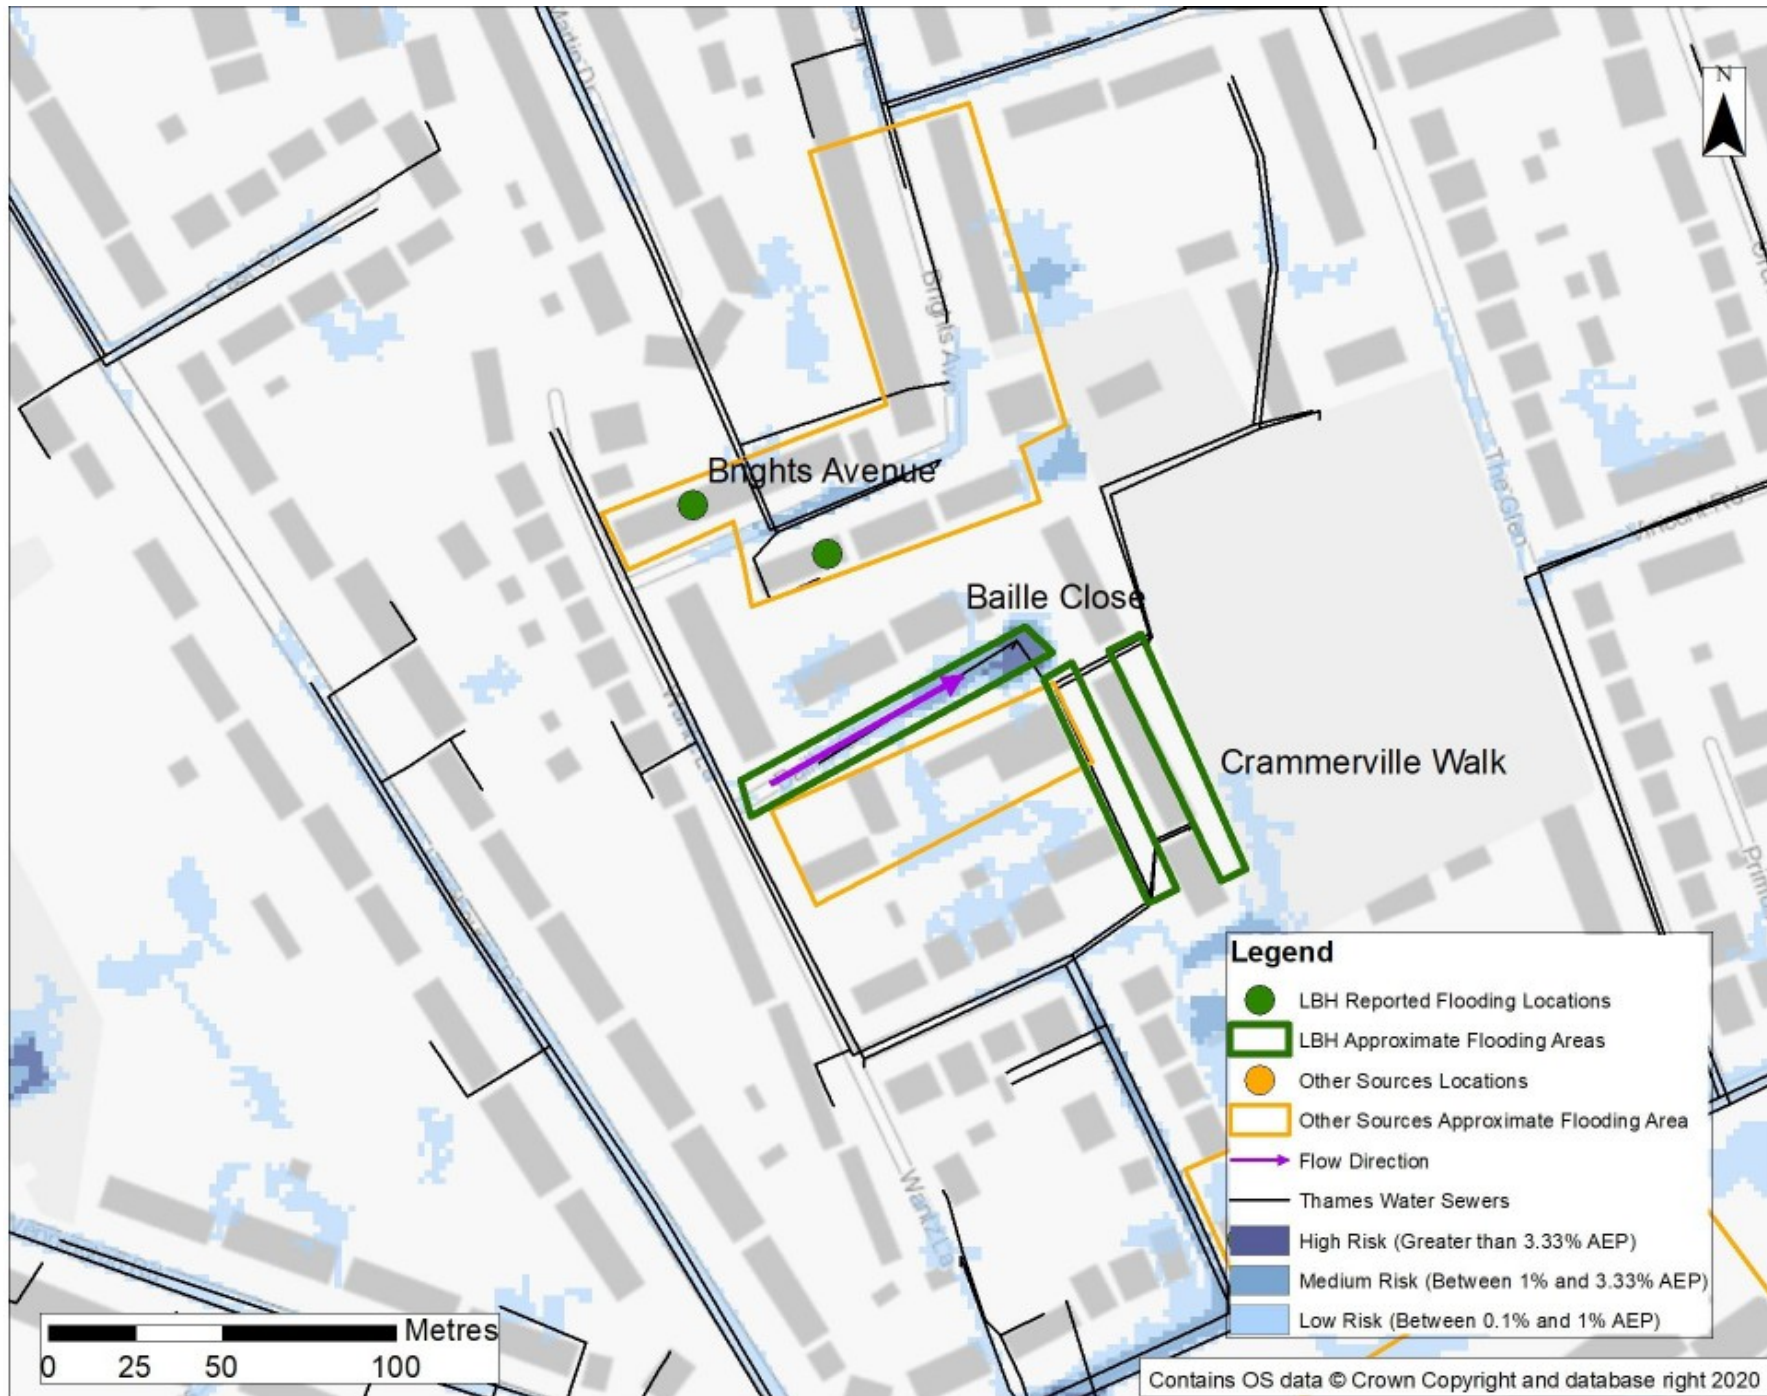
A.10 Brights Avenue and Baille Close

11. Brights Avenue and Baille Close	<ul style="list-style-type: none"> Properties along Brights Avenue appear slightly elevated above road level. Unclear how property along Avenue (north side) experienced internal flooding, given footpath directly at front of property raised and property also separated from the footpath by a short brick wall. Unclear if surface water could have entered property from the rear. Topographical low point at end of Baille Close, where intersects with Crammerville Walk. Observed ground levels support flow path along Baille Close and ponding of water at the bottom (north) of the Close. Unknown location of reported carriageway flooding along Baille Close. No gullies observed along Crammerville walk (reported carriageway flooding). One gully observed along what could also be considered Crammerville walk (parallel footpath at the edge of the residential area and the Glen Open Space).

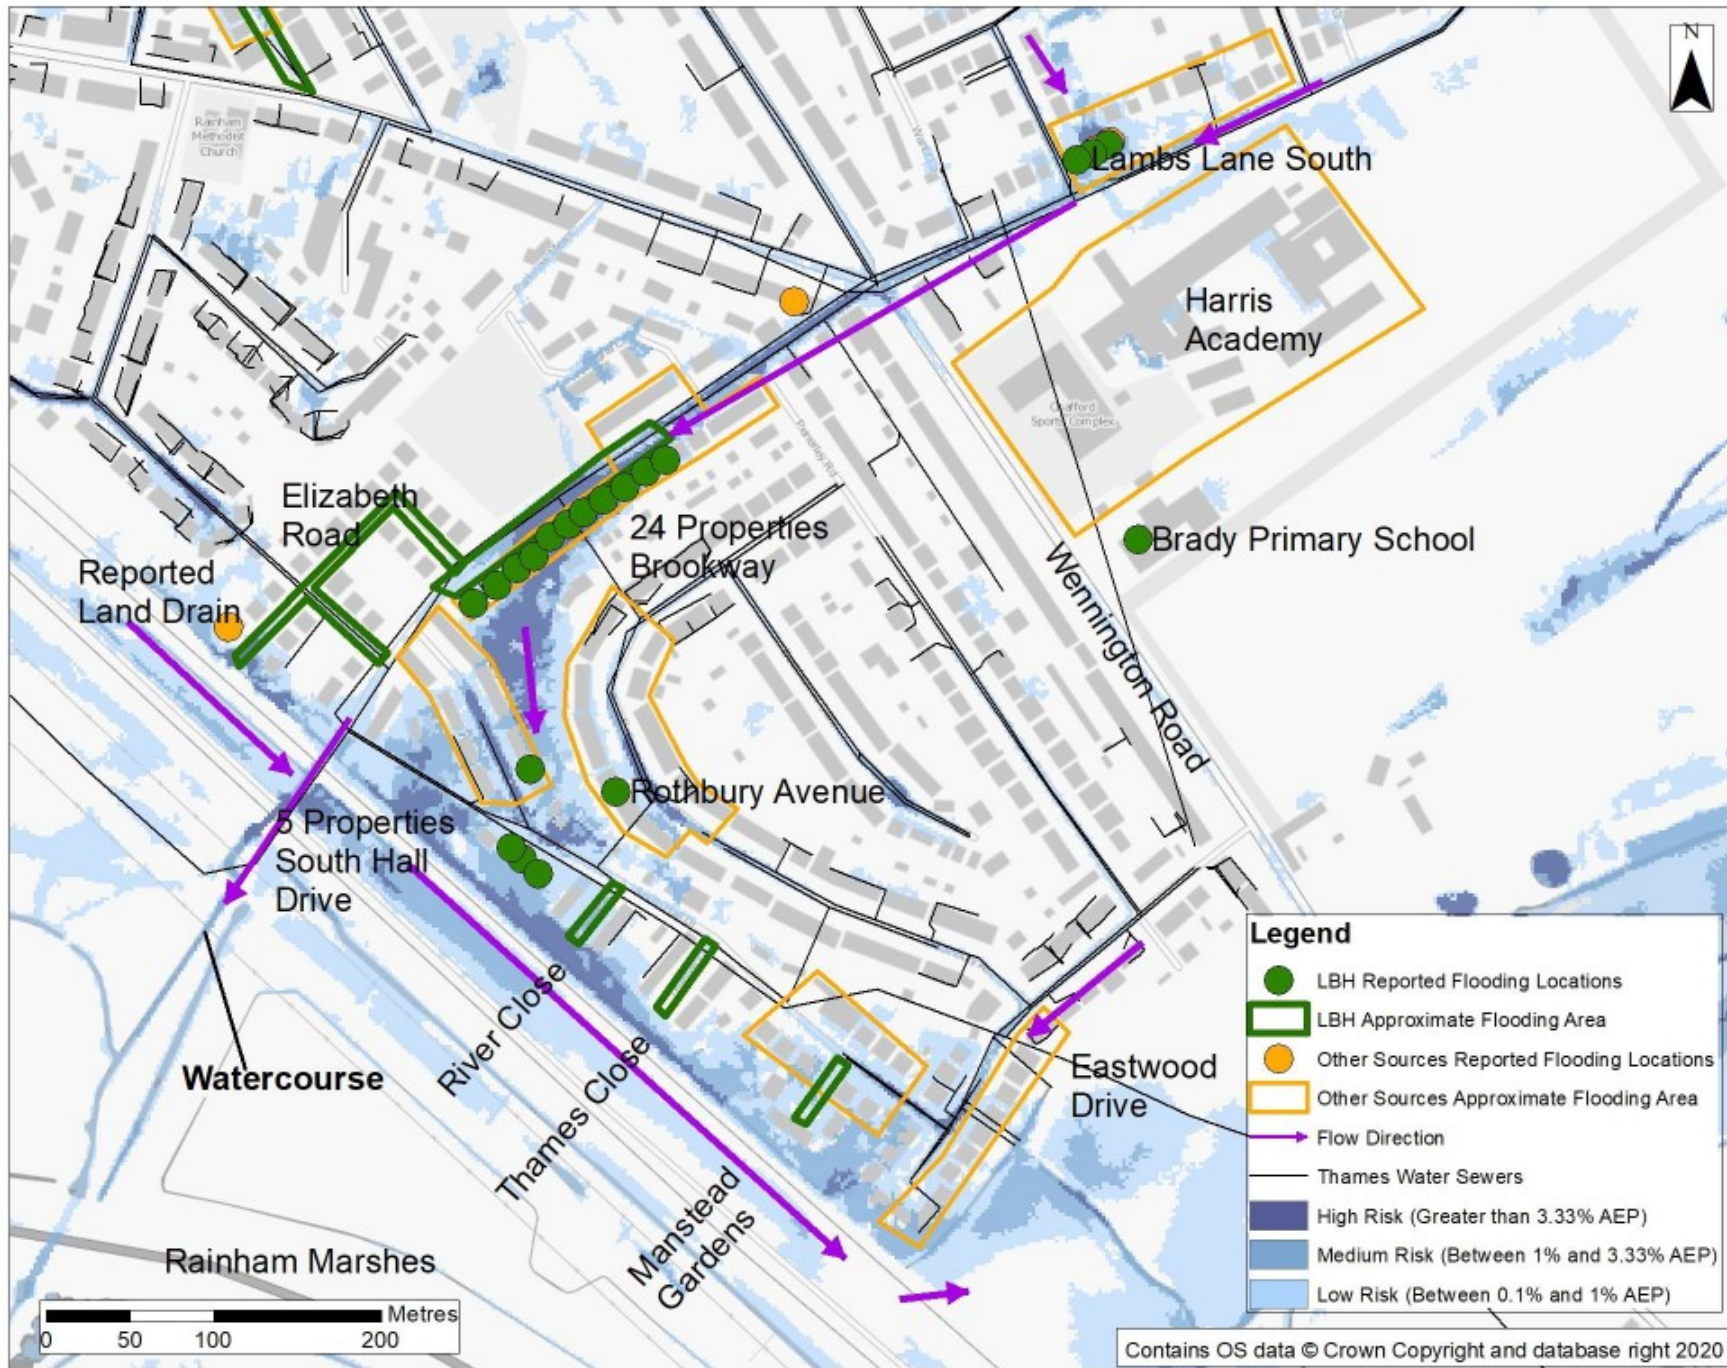
A.11 Brookway and South Rainham

12. Brookway & South Rainham	<ul style="list-style-type: none"> Gushing manhole heard on site at the southern end of Brookway, believed to be TW asset, location of which is included in the TW asset data. Network Rail owned land between the residential area and the railway line itself observed to be approximately 1m lower than the railway line. Small watercourse observed flowing south from the bottom of Brookway (edge of residential area) through a headwall/culvert under the railway line. Watercourse then believed to flow south, through the marshes, under the A13 via a culvert, through sluices gates at the southern edge of the marshes (which are believed to control the water level of the watercourse and within the marshes), eventually discharging to the River Thames.

The flooding observed at location 12: Brookway and South Rainham (Figure A11, Appendix A) is a location from the August 2020 event where the magnitude of impact appears to be potentially underestimated by the reporting. The locations of observed flooding correlated fairly well with the EA RoFSW mapping flood risk extent. However, based on the range of event frequencies estimated for the August rainfall event, less properties would be expected to have been affected. This suggests the EA RoFSW mapping could be presenting an underestimation of potential flood risk or, as previously discussed, that the rainfall event was of a greater magnitude than the analysis suggests. The reports of flooding in this location suggest potentially a lack of capacity of the sewer system could have contributed, with no evidence of obvious blockages or failures with regard to assets or infrastructure.

Various stakeholders and FRMAs have provided views on the contributing factors to the observed flooding in this location. Observations and anecdotal evidence provided by LBH for instance, suggests that the TW sewer is reportedly often carrying flows even a significant time after rainfall events, indicating slow discharge and that the system may therefore not have capacity during the heavy rainfall events. The TW system is believed to be of an insufficient gradient along Brookway, and as such controlling the discharge rate to the open ditch at the southern end of the road and the edge of the residential area.

The drains at the southern end of Brookway and running parallel to the edge of the residential area are believed to have been full around the time of the event. Anecdotal evidence from LBH suggests that the drain shown in Figure A11 (Appendix A) and represented by the RoFSW mapping to be flowing north-west to south-east was in fact flowing the opposite direction, towards the TW outfall and drain at the bottom of Brookway. NR reported that their culvert under the railway line was observed on a site visit prior to the event to have been "drowned" by high water levels from the marshes. Both the NR culvert and the TW outfall pipe were observed to be submerged but not silted. It is believed the water levels in the area are controlled by the three EA owned and operated sluice gates, downstream of the residential area (within the marshes, near Coldharbour Lane). Responses from NR and LBH suggest that the elevated water levels within the marshes are a significant factor in the observed flooding of the residential area. In addition, it is also believed that there is the potential for the water levels in the marshes to be tidally locked by the Thames River.

It is considered not possible without further investigation to delineate one or several sources as a primary cause of flooding at this location. It is likely that the observed flooding at this location is driven by some combination of the above mechanisms, as described by the various FRMAs.

As it was not considered possible to delineate one or several sources as a primary cause of flooding to the areas near Brookway, South Rainham, where considerable property flooding occurred, it is recommended a separate investigation be undertaken. This investigation should aim to more fully understand flooding in the area and allow agreement of an updated, cross-agency Water Management Plan for the marshes and surrounding areas, including participation from TW, RSPB, LBH, EA and NR. The plan could include agreed upon emergency response procedures in the event of predicted severe weather and will facilitate joint understanding of the overall hydrology mechanisms in the area and cooperation between the agencies towards preventative measures through joint management.
