Havering Flooding, June 2016

London Borough of Havering

Flood Investigation Report

20 January 2017

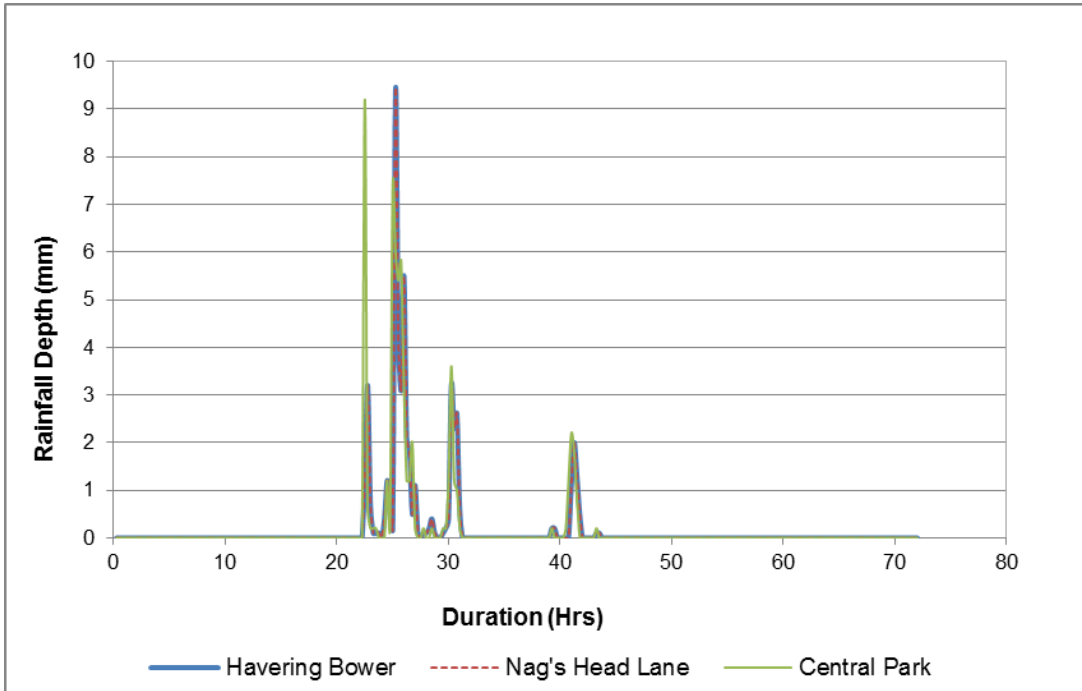
Figure 1.2 shows the rainfall recorded during the event at the three local rain gauges.

Figure 1-3: Rain gauge recordings

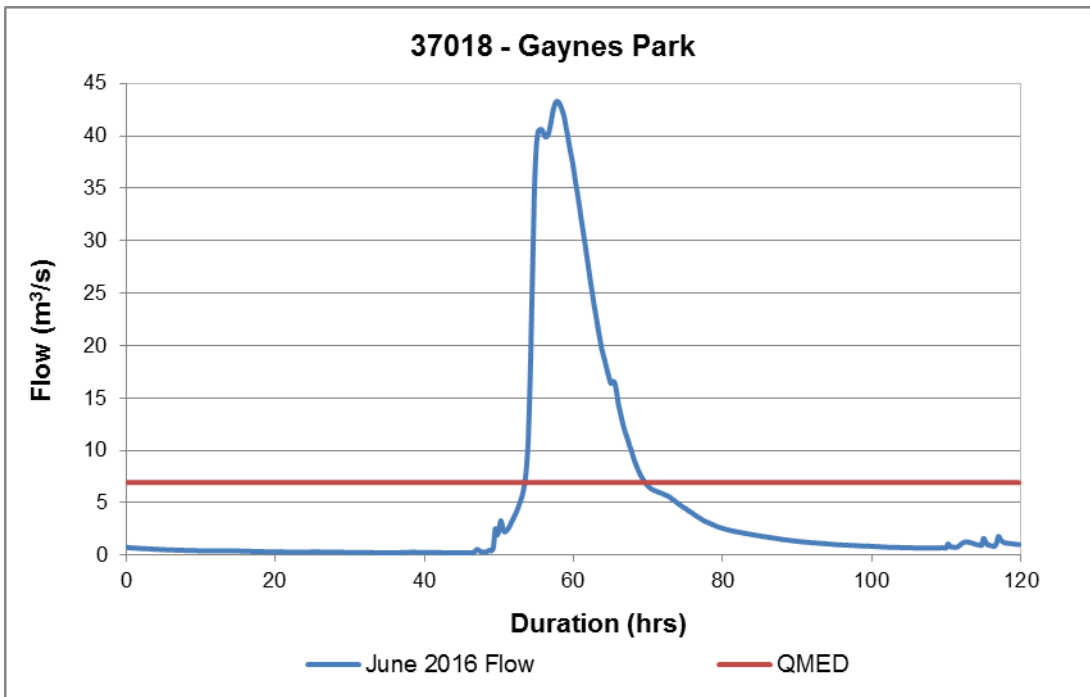
Figure 1-4: QMED against June 2016 event at gauging station 37018

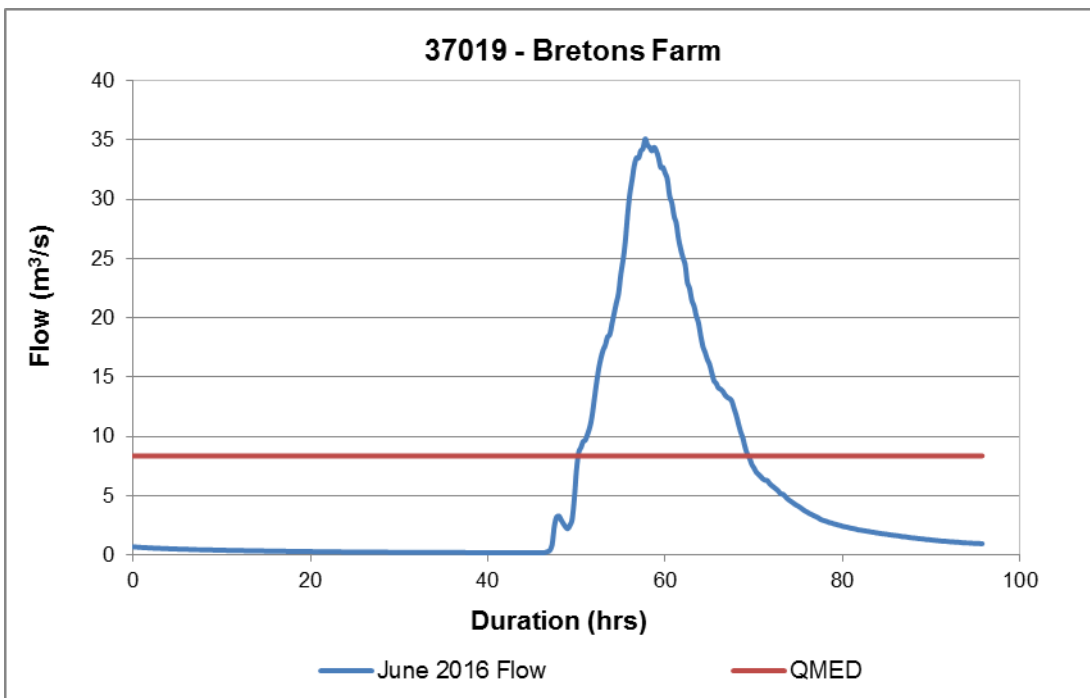
Figure 1-5 : QMED against June 2016 event at gauging station 37019

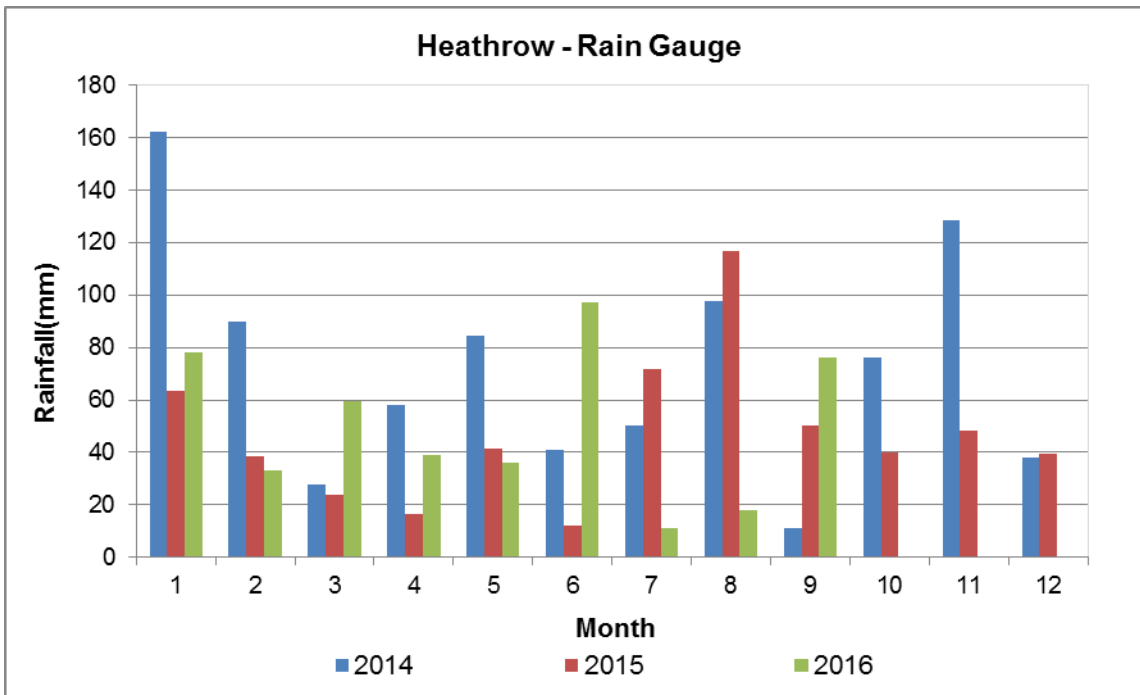
Figure 1-6: Comparison of three year rainfall data at Heathrow

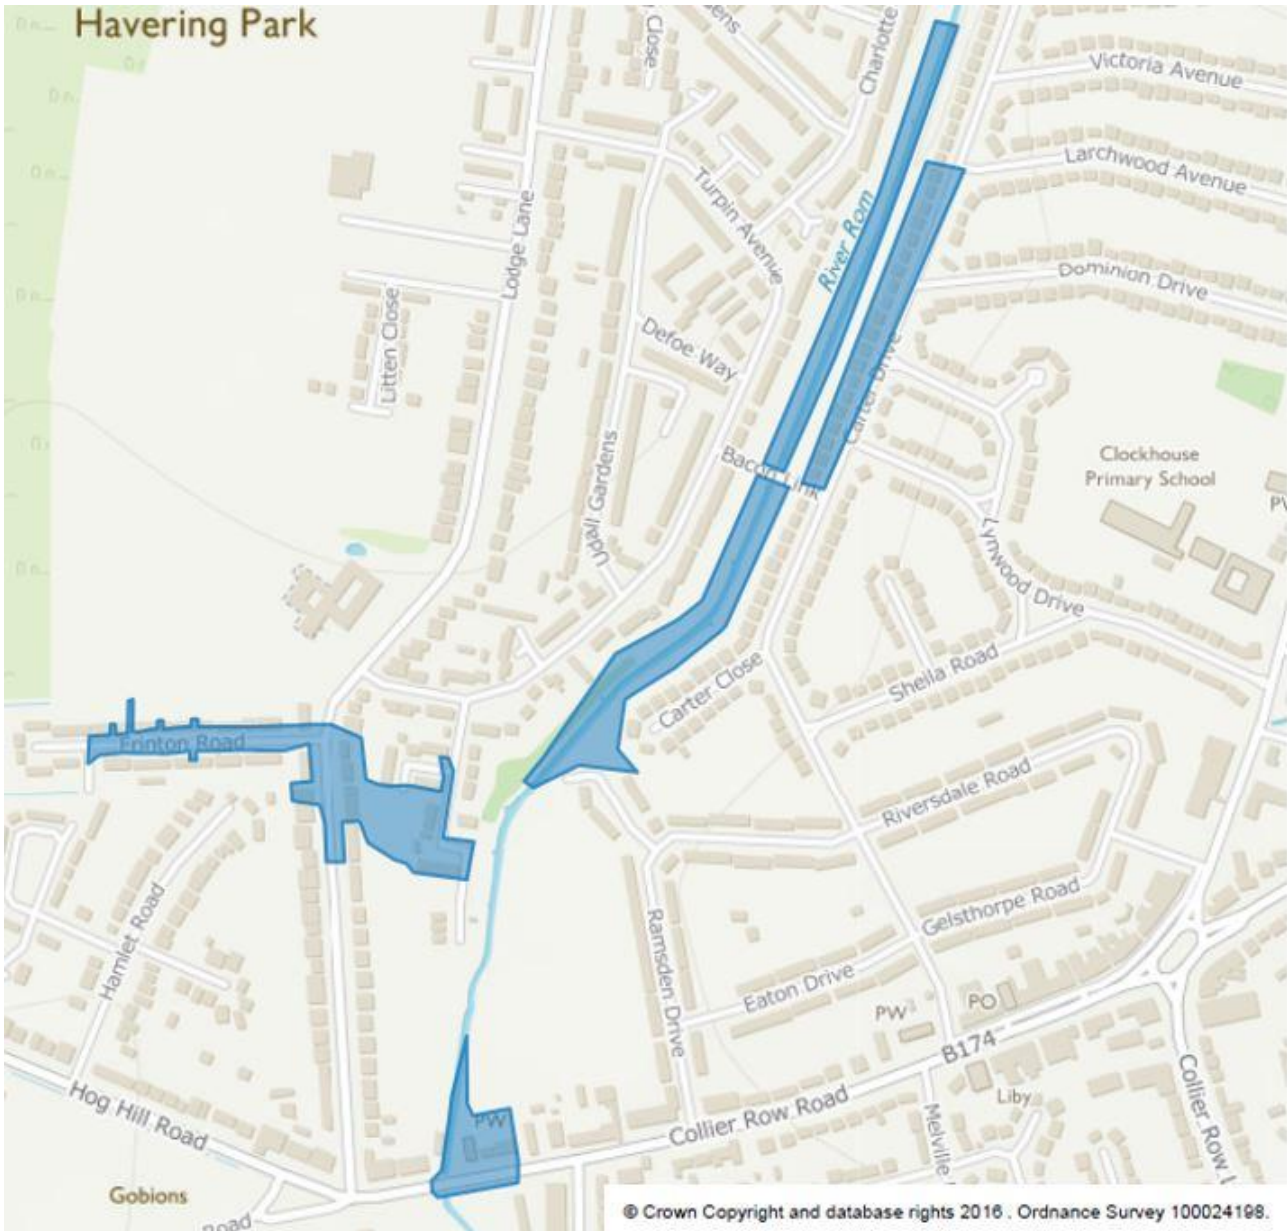
During the early hours of 23 June, a significant thunderstorm passed over the Romford area resulting in 30mm of intense rain falling over the area in a 2 hour period. A total of 52mm of rain was recorded over 7.5 hours at the nearby Central Park tipping bucket rain gauge. The River Rom and adjoining surface water sewers had insufficient capacity to cope with the surface water run off which resulted in flooding to the local area.

Figure 4: A map of the Havering Park area showing the extent of flooding 23 June 16

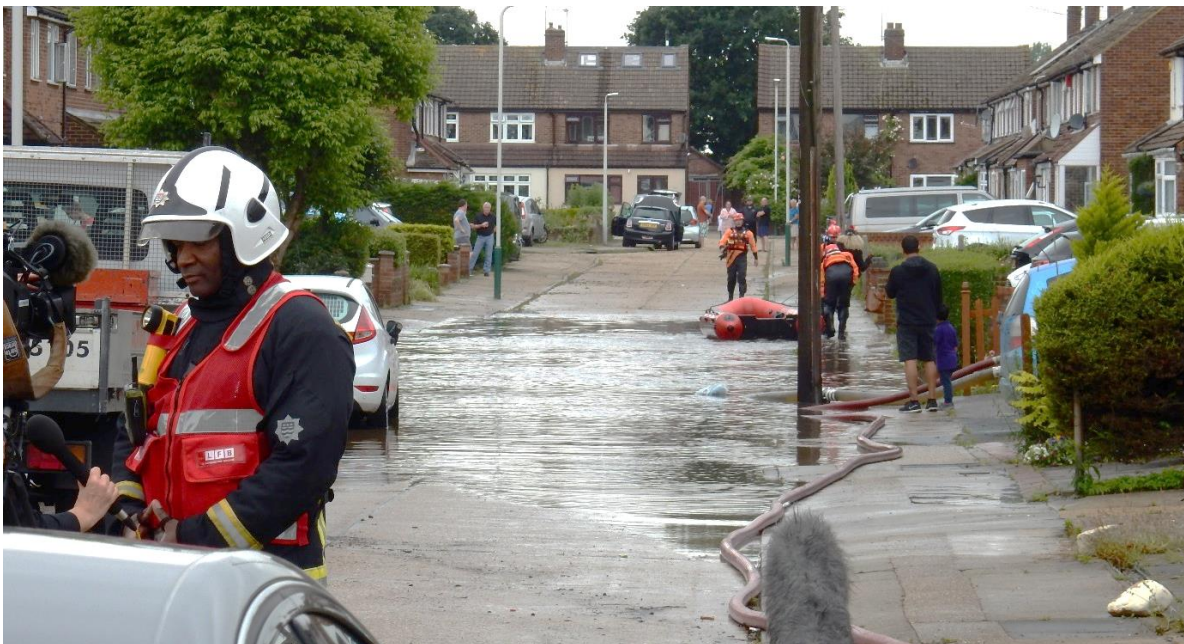
Figure 6: Photo showing surface water on Frinton Road at 12:42pm, 23 June 16. The emergency services carrying out a media interview. LFB evacuated residents to safety by boat. Taken from the Frinton Road/Lodge Lane junction, facing west.

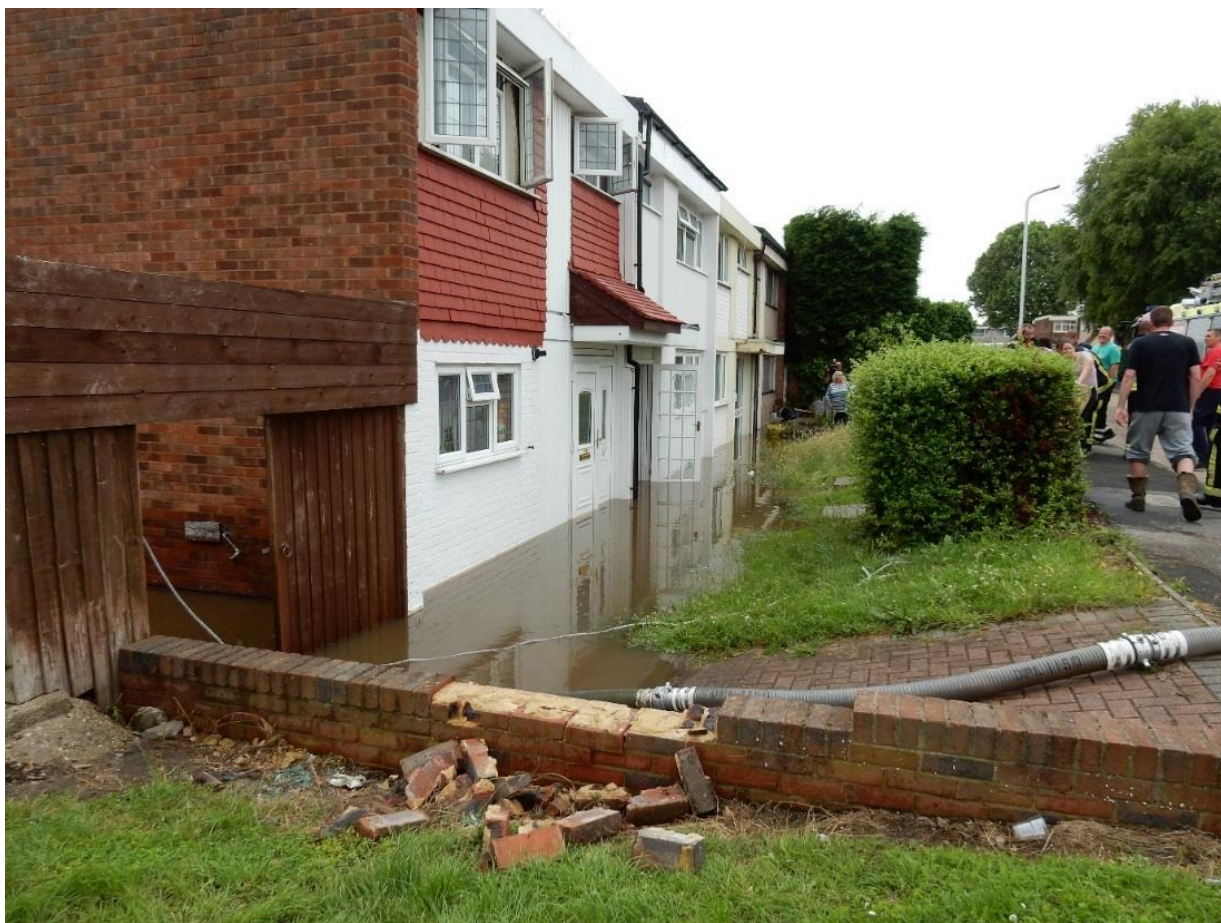
At Penn Gardens, 10 properties flooded internally. Residents of 4 properties on the western side of Penn Gardens were evacuated due to deep water pooling in and around properties. The property level is significantly lower in this area than road level. Water was being pumped from the properties into the River Rom by the fire brigade.

Figure 7: Photo showing properties on Penn Gardens at 12:19pm on 23 June 16. These properties had been evacuated by LFB and were being pumped out.

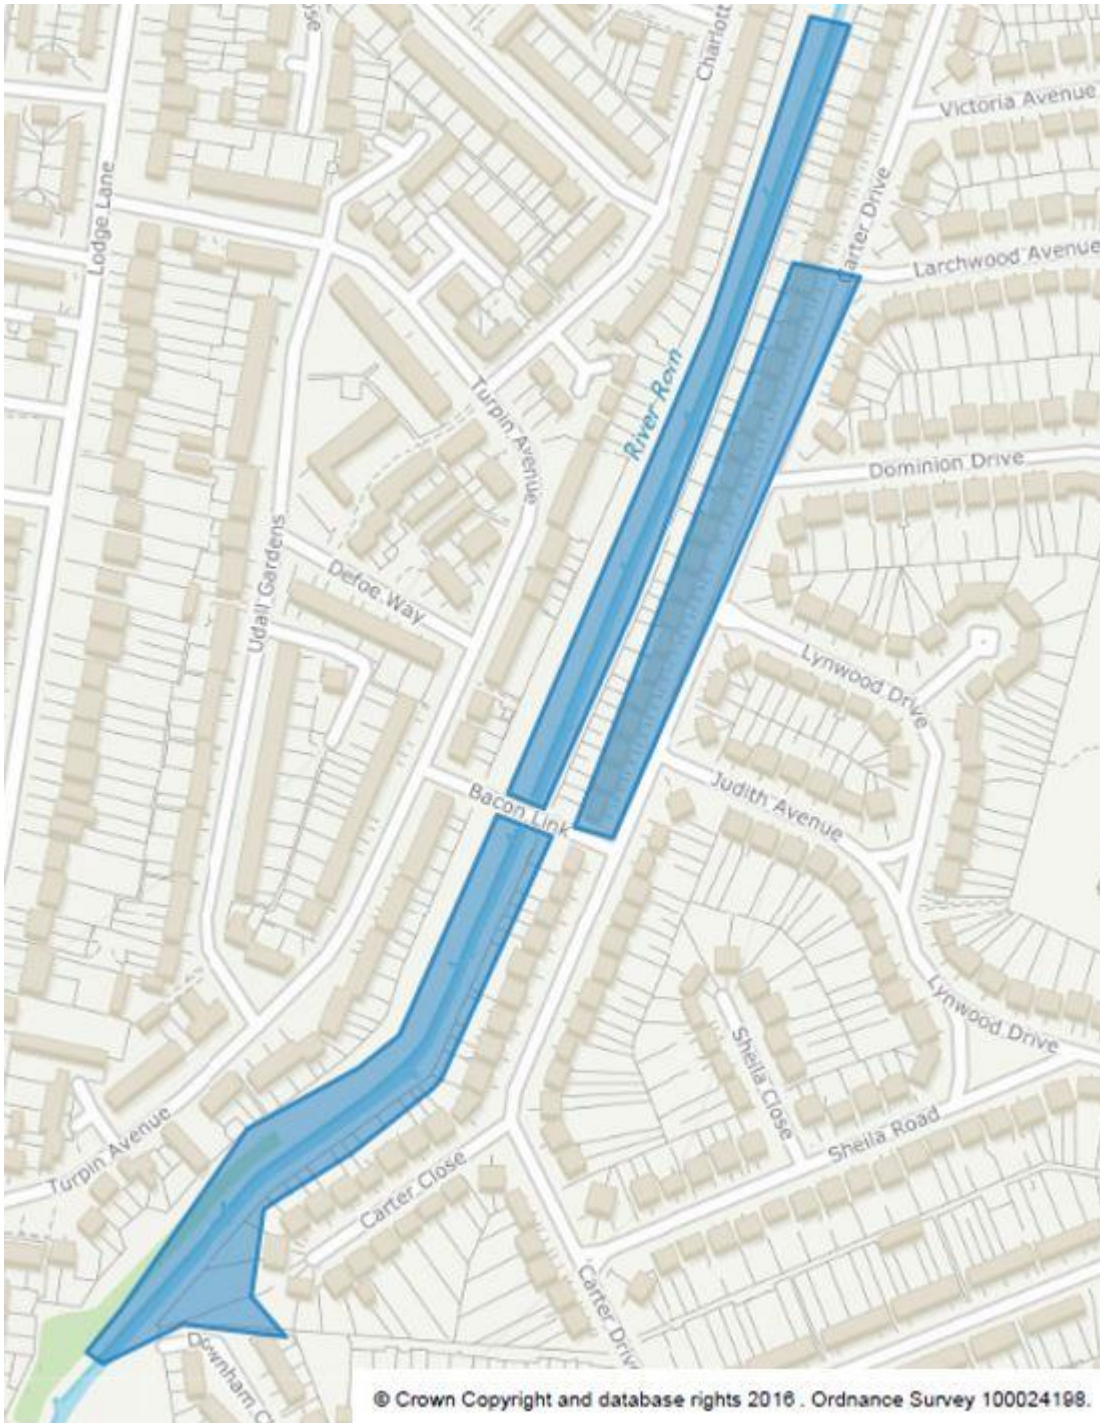
Figure 8: A map to show the flood extent on Carter Drive and Carter Close, Romford, 23 June 16

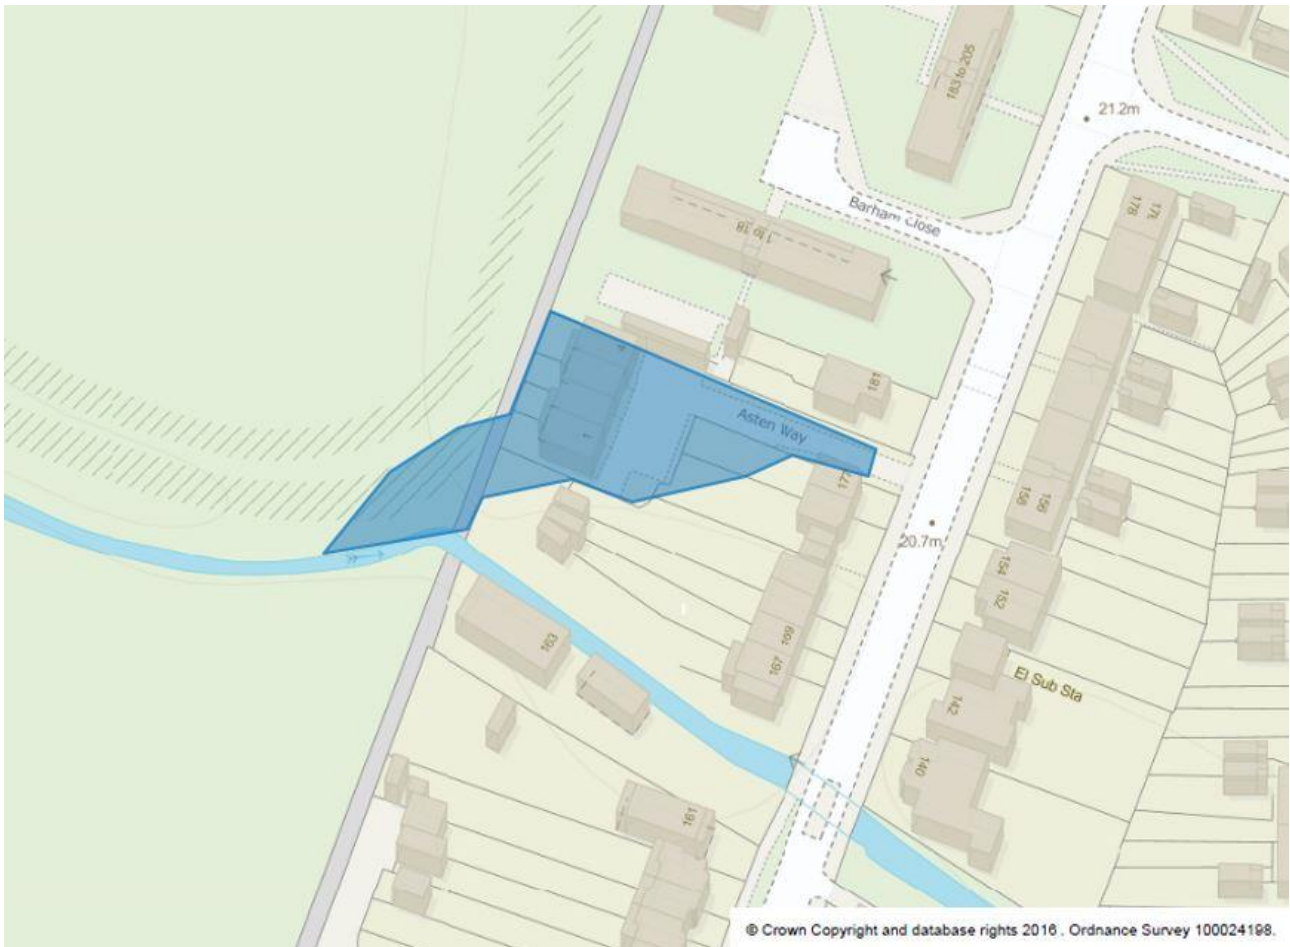
Figure 10: A map showing the estimated flood extent at Asten Way, Romford, a new housing development, 23 June 16

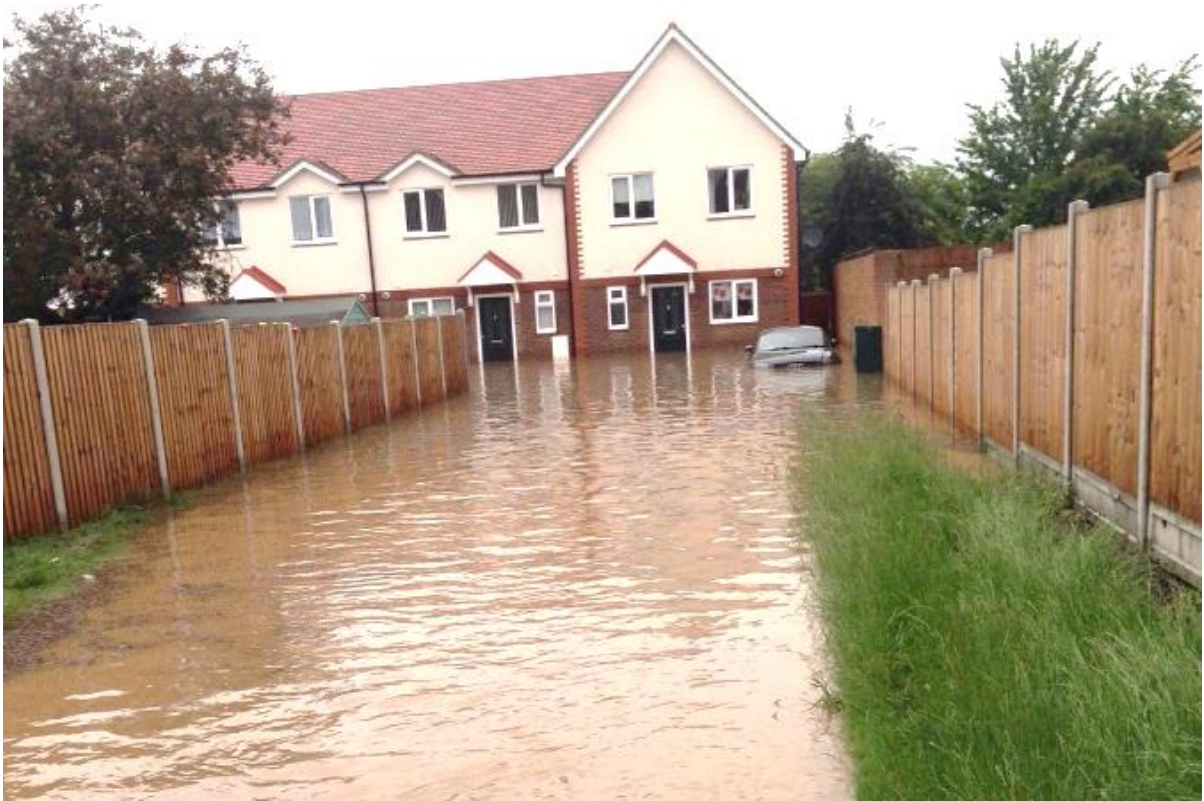
Figure 11: Photo from resident of Asten Way, showing flooded properties on Asten Way, Romford, 23 June 16

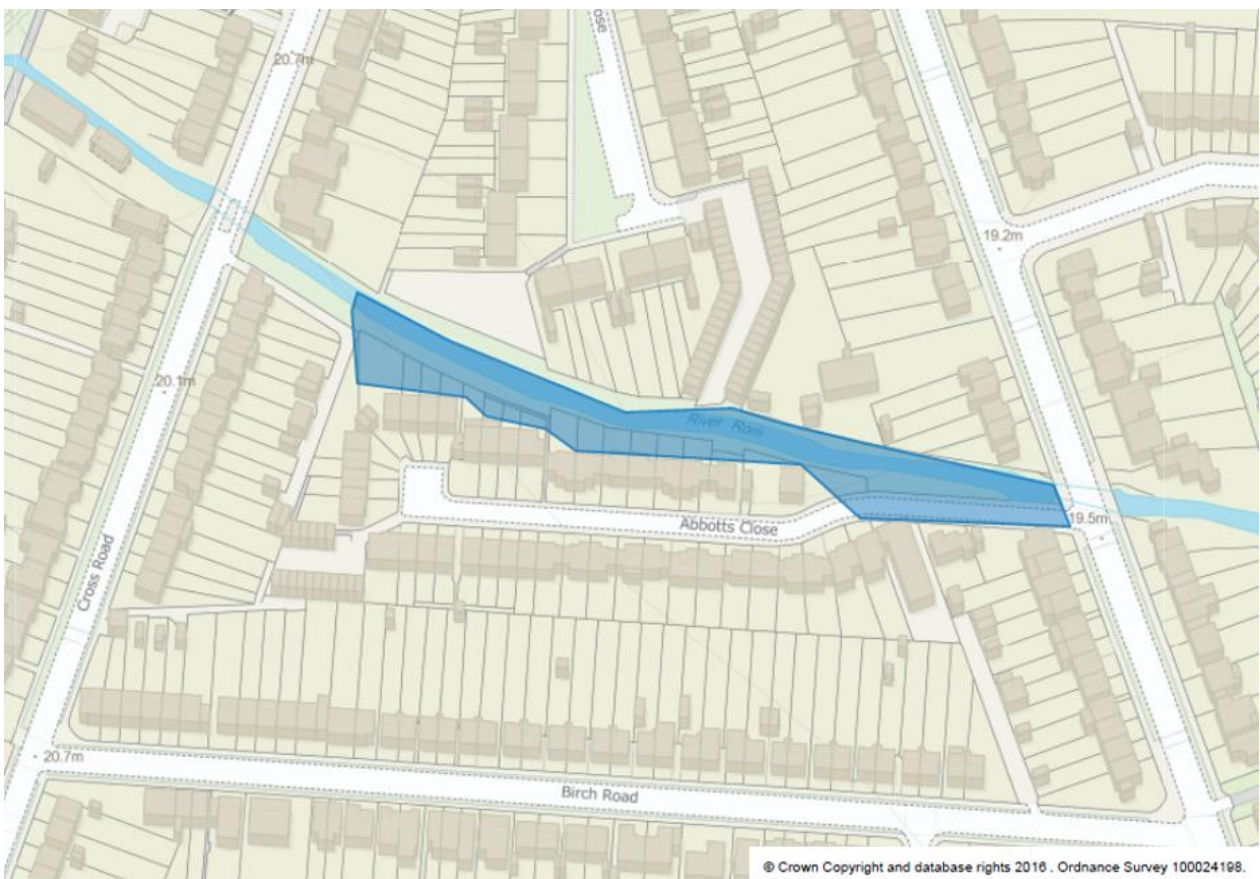
Garden flooding occurred to up to 16 riverside properties according to a resident in Abbotts Close, however FISOs were unable to attend the site to confirm this.

Figure 12: A map showing the estimated flood extent at Abbotts Close, 23 June 16

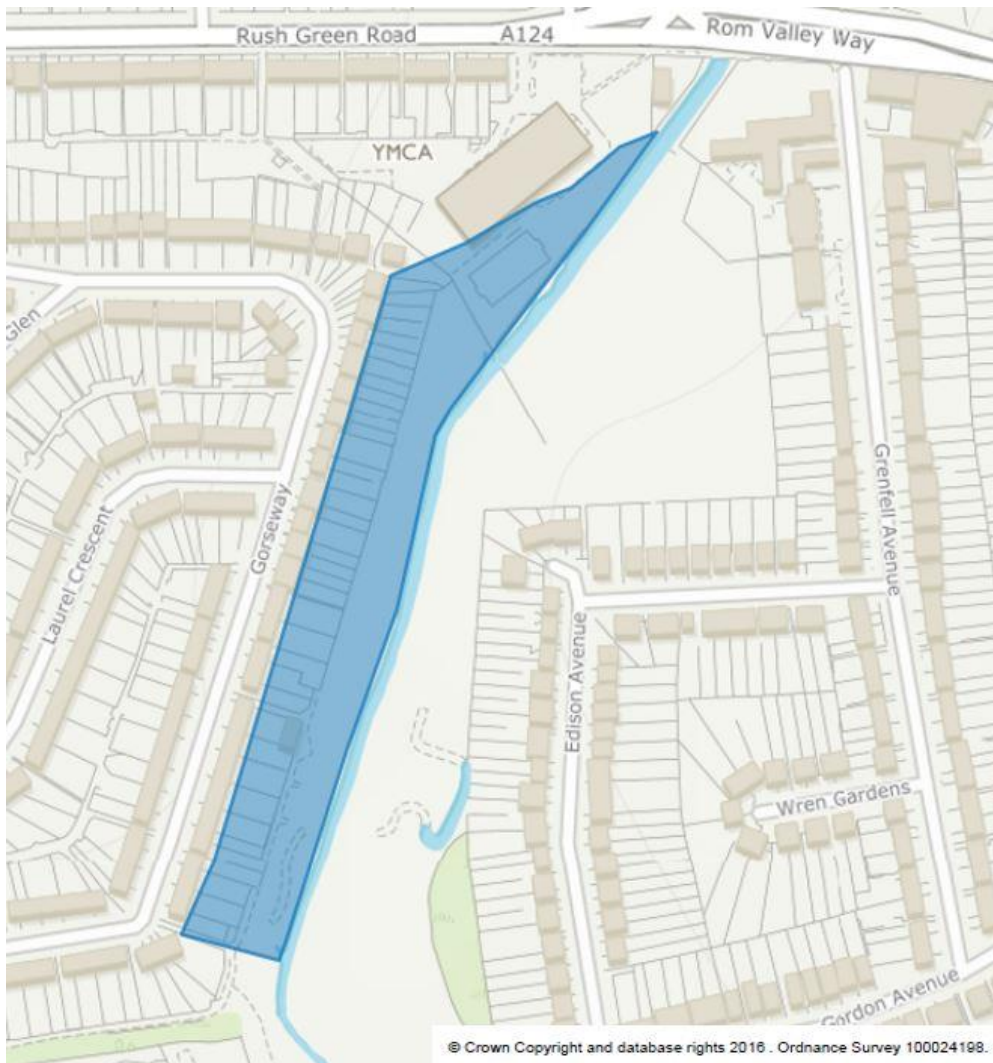
Figure 13: A map showing the flood extent at Gorseway, Romford, 23 June 16

Threshold levels at Romford flood warning telemetry site, have been reviewed since the June flood event and have been lowered based on the flooding that happened at Gorseway. This means that our flood warnings will be triggered at a lower river level being reached in future.

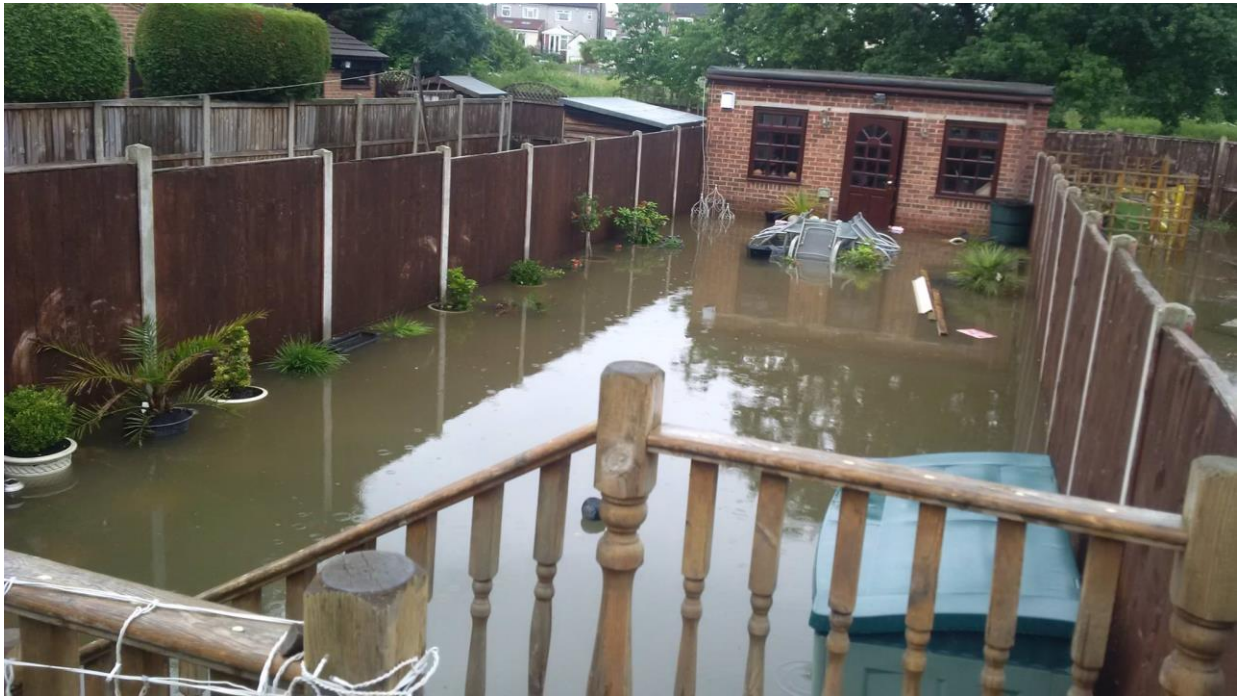
Figure 14: Photo showing a property garden affected by flooding on Gorseway. Water levels are representative for other properties on Gorseway affected by high river levels on the Rom, 23 June 16.

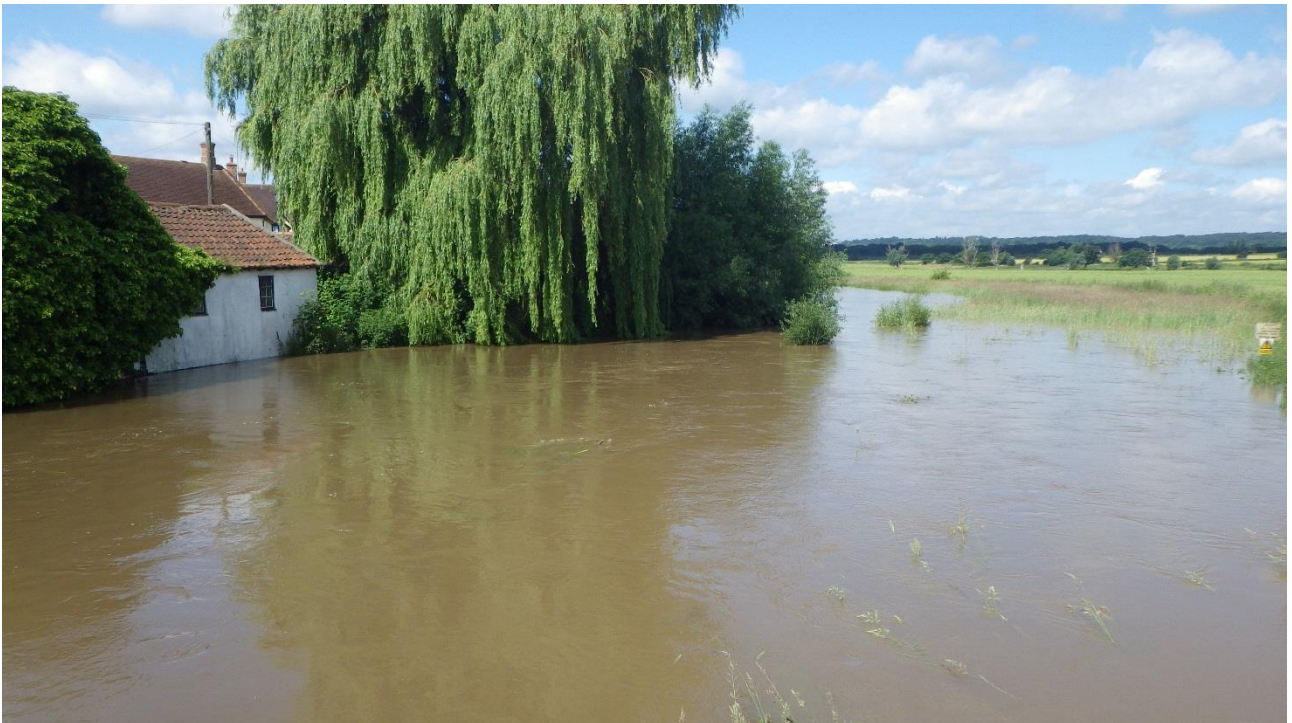
Figure 16: A picture showing high water levels looking down steam at Abridge, 23 June 16

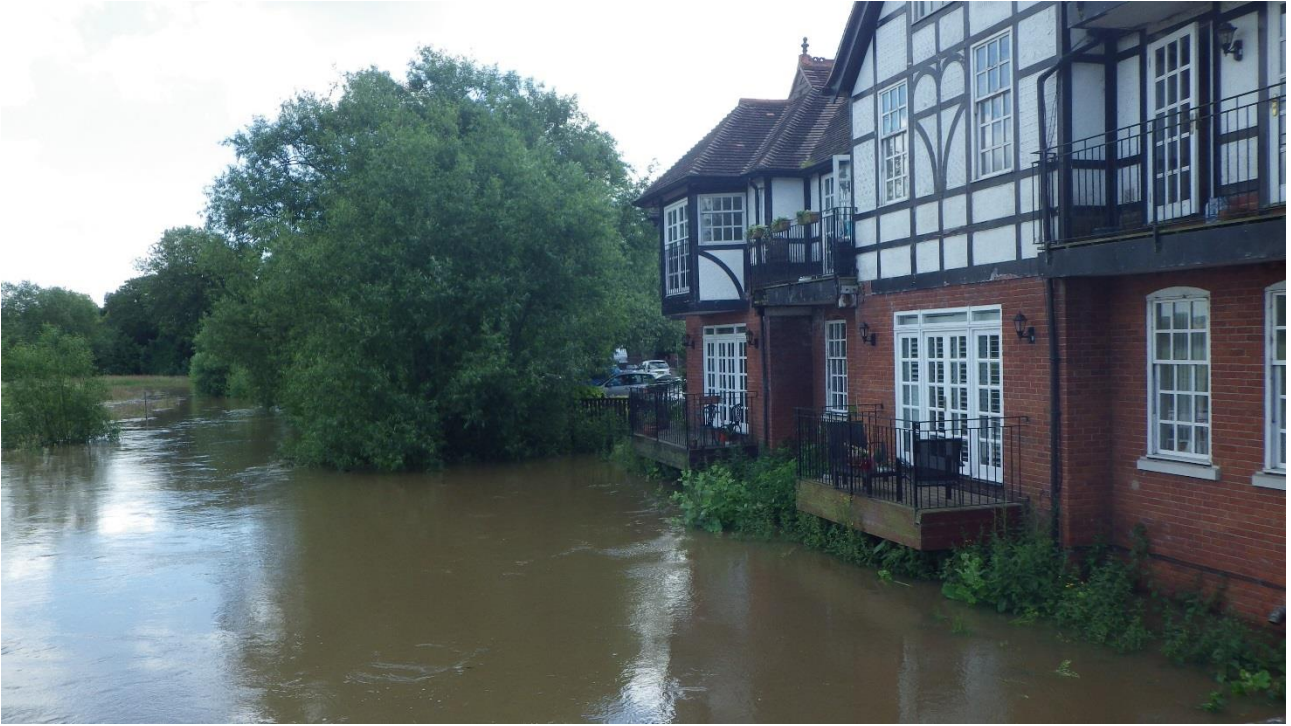
Figure 17: A picture showing high water levels looking up stream at Abridge, 23 June 16

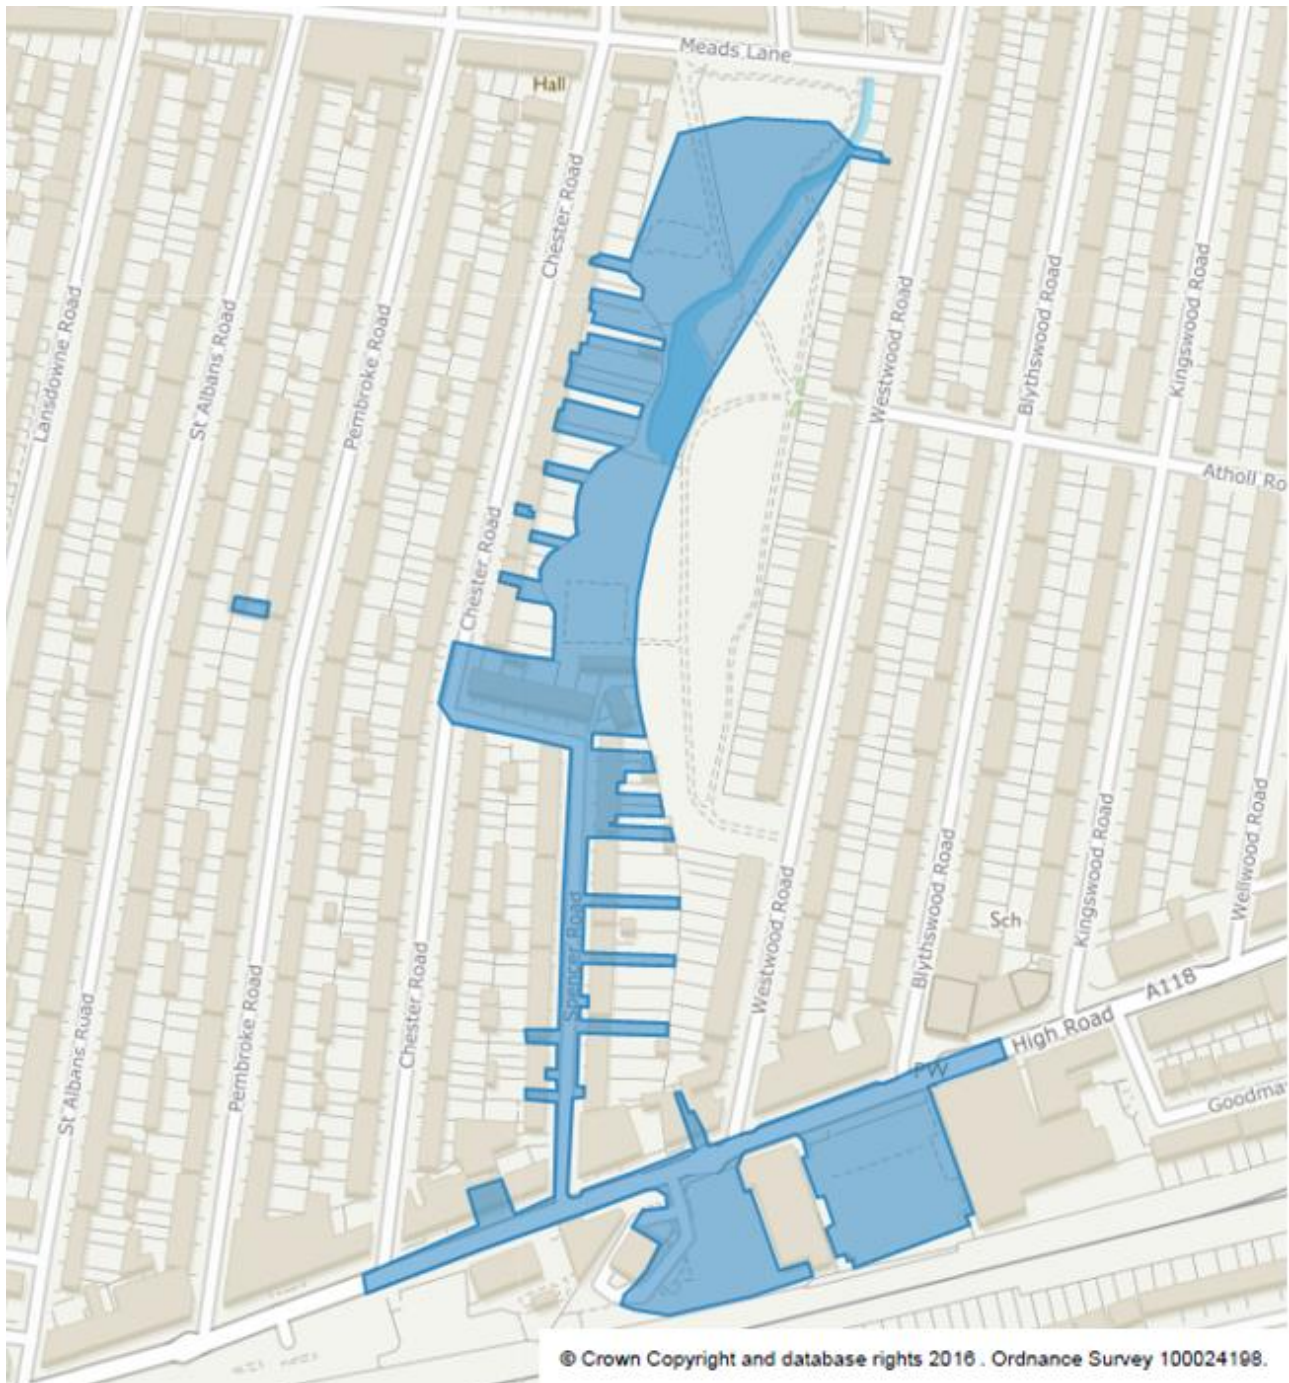
Figure 18: A map to show the flood extent in the Seven Kings Water area, based on information received from residents and observations made by FISOs and LB Redbridge.

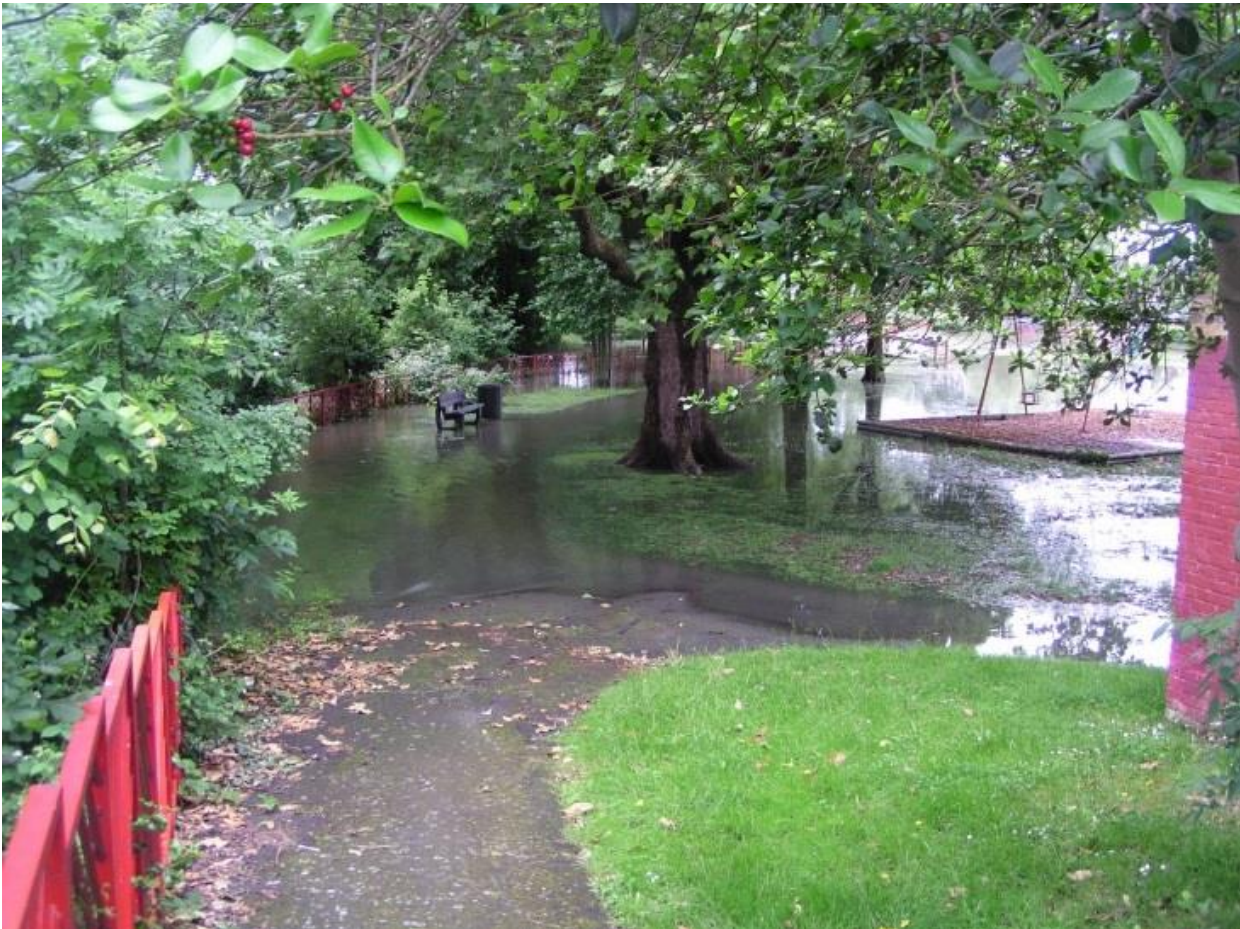
Figure 19: A photo showing flooding to Westwood Park, where the river came out of banks, 23 June 2016

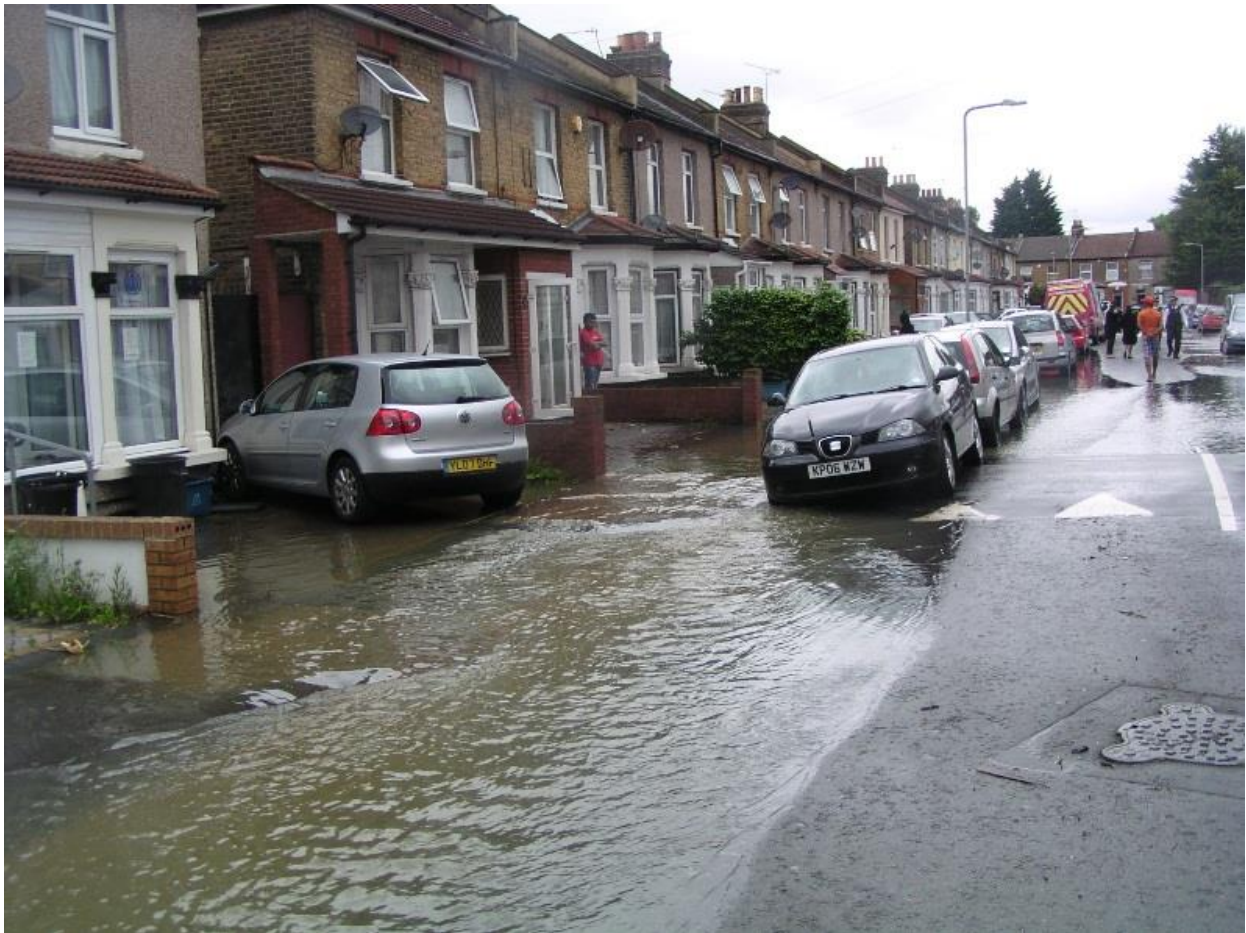
Figure 20: A photo showing flood water looking north along Spencer Road. Water is flowing south towards the A118 High Road, 23 June 16.

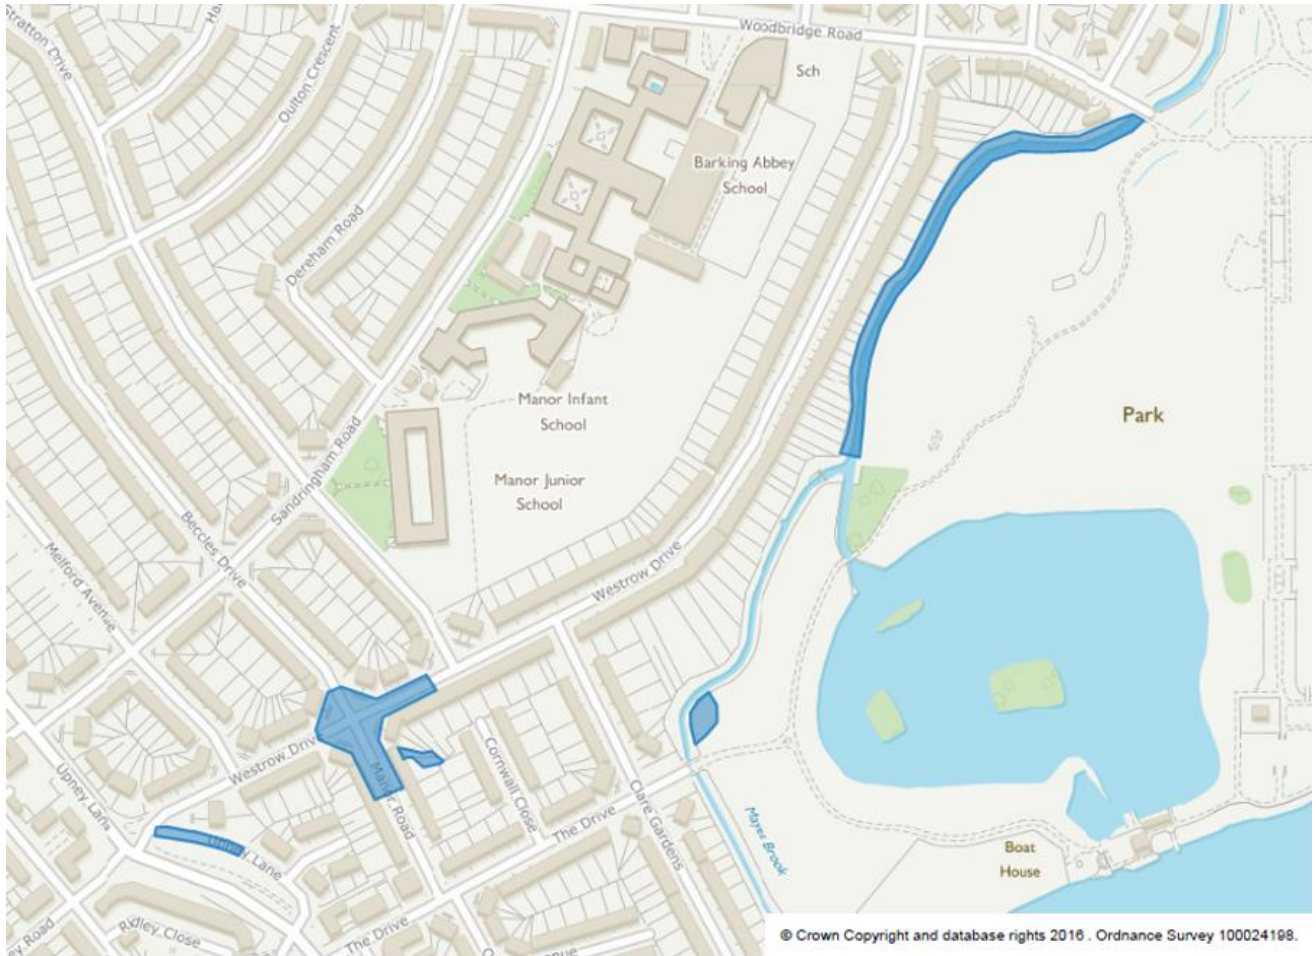
Figure 22: A map showing the known flood extent in the Upney area, 23 June 16

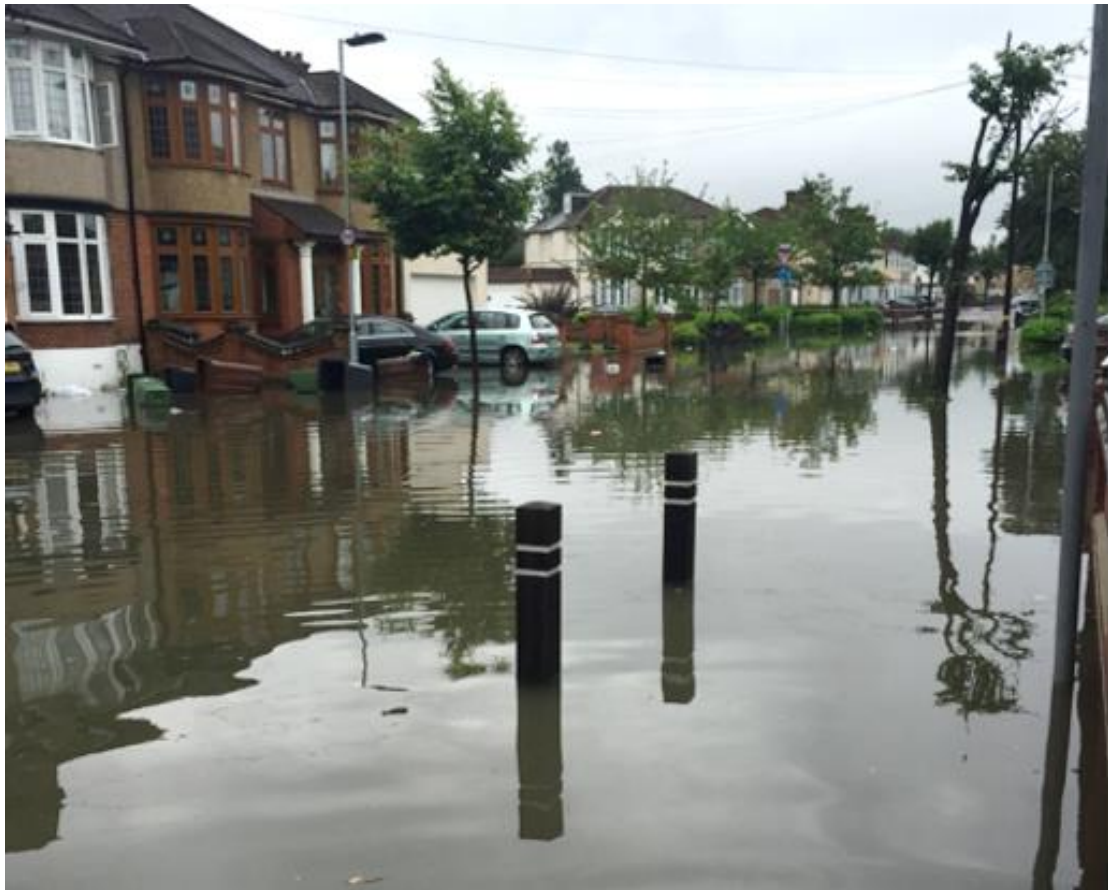
Figure 23: Photo taken by local resident taken on the morning of 23 June 16. Facing south west on Westrow Drive looking towards the junction of Manor Road and Westrow Drive showing road flooding along Westrow Drive.

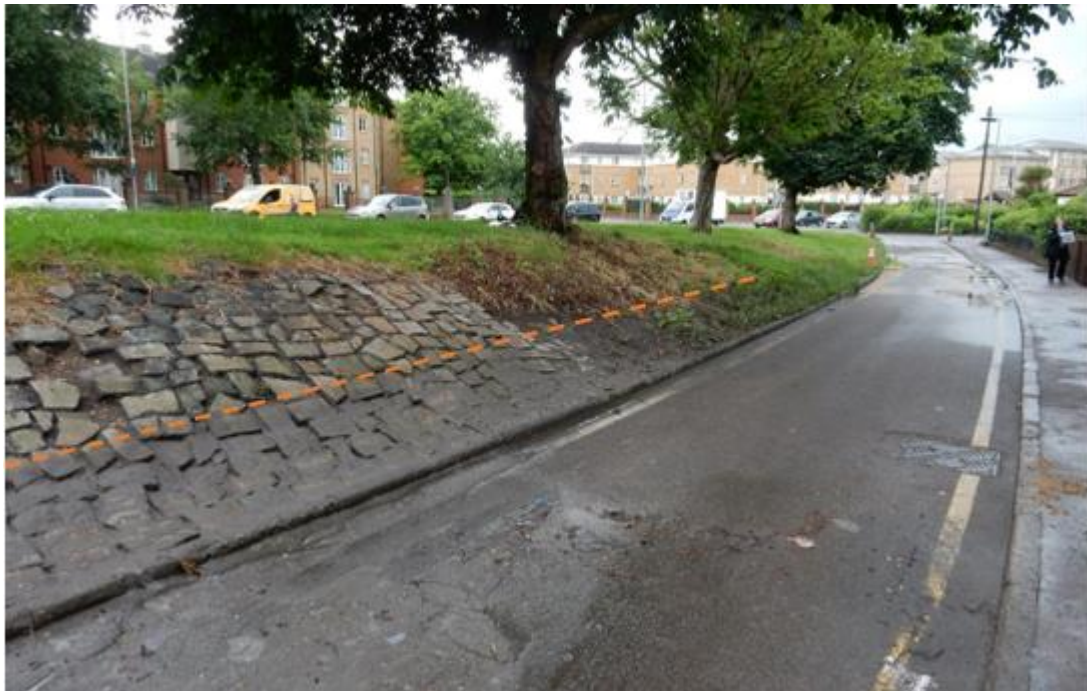
Figure 24: Photo taken at 4:43pm on Steven Jewers Gardens. Looking northwest towards the junction with Westrow Drive. Strong odour on site. Evidence of flooding from silt remnants in road. Note water line on stone banking, (orange line) approximately 0.5-0.7m up from road level.
