Havering Flooding, June 2016

London Borough of Havering

Flood Investigation Report

20 January 2017

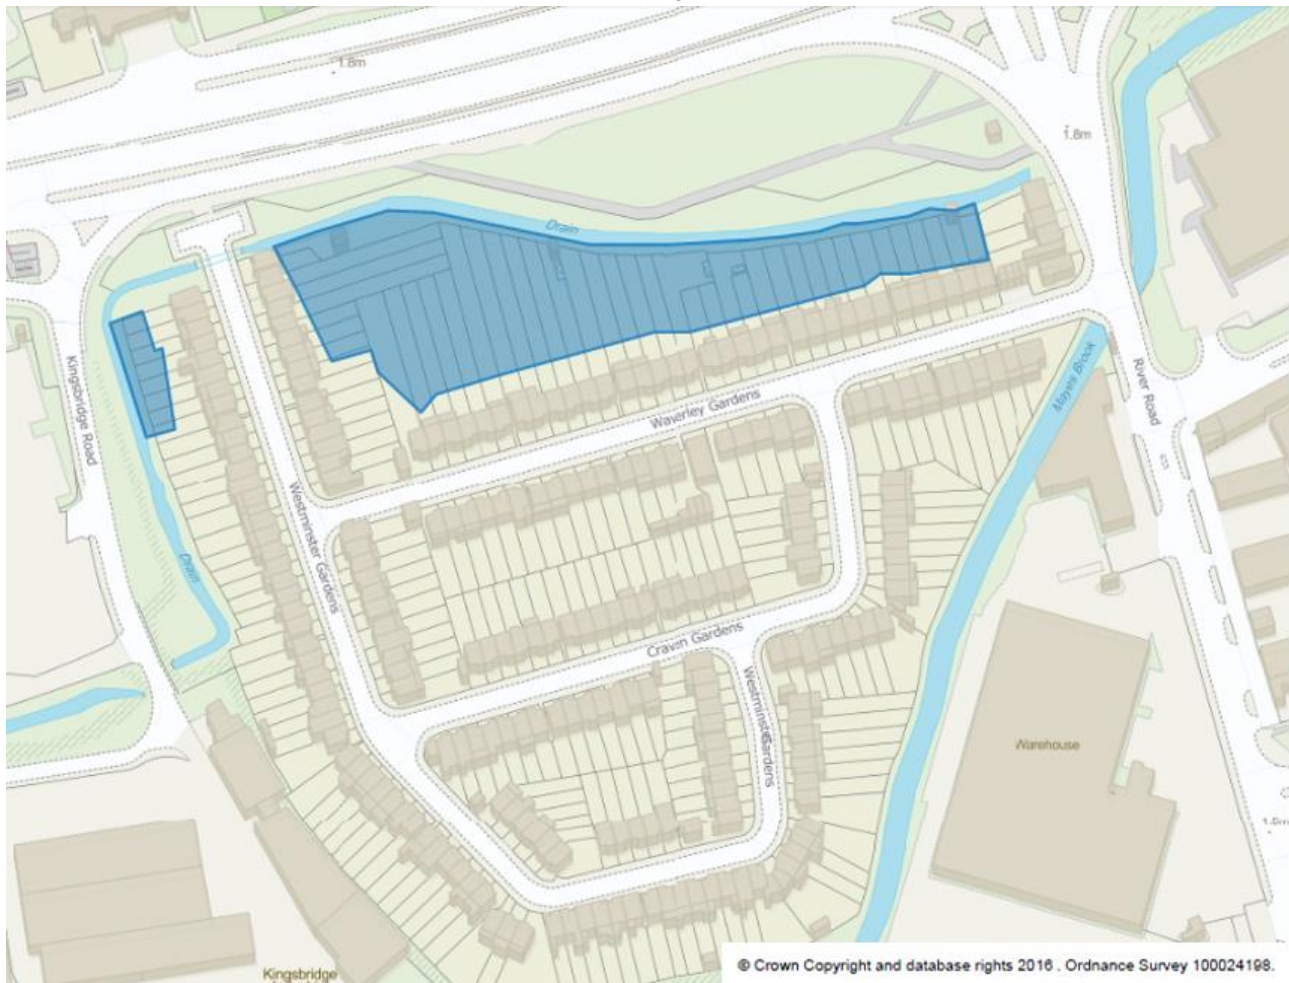
Figure 25: A map to show the flood extent at Waverley Gardens and Westminster Gardens

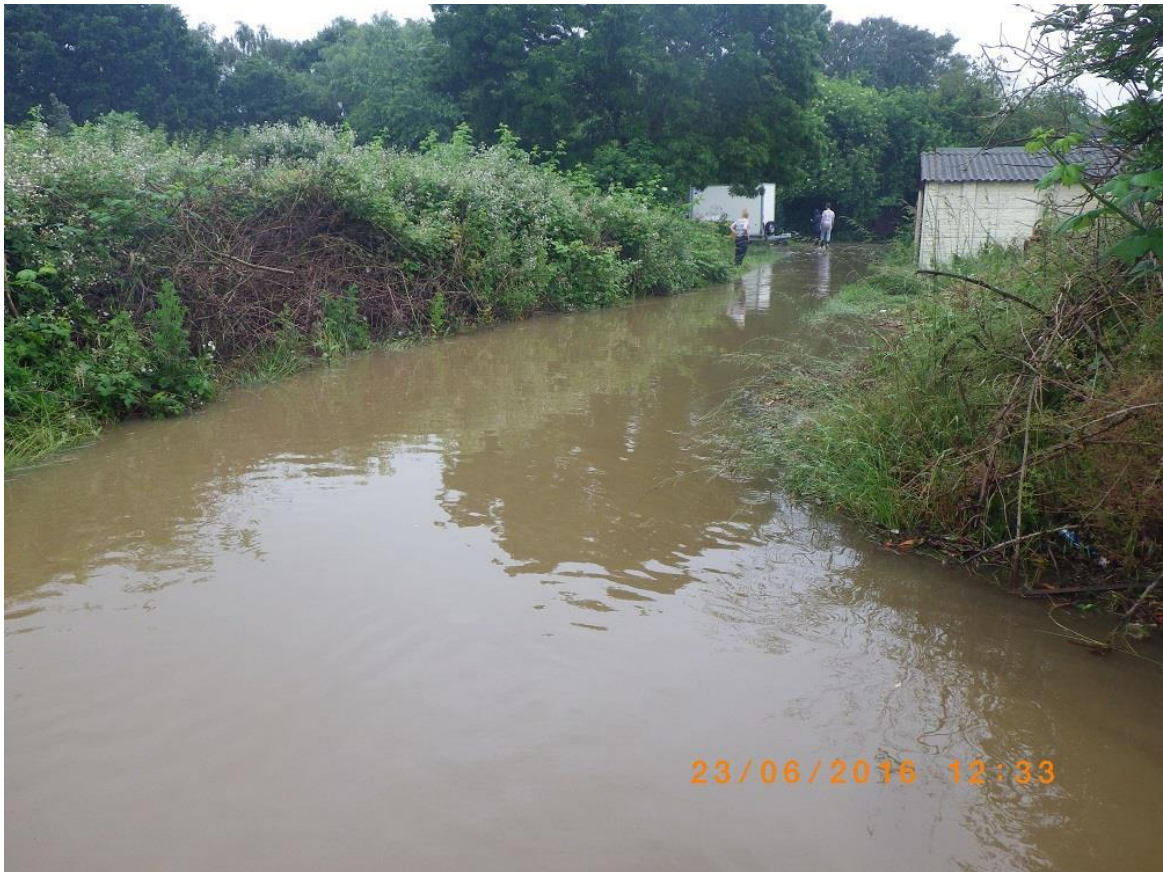
Figure 28: Photo looking SSW, showing flooding on a track behind Frimley Avenue

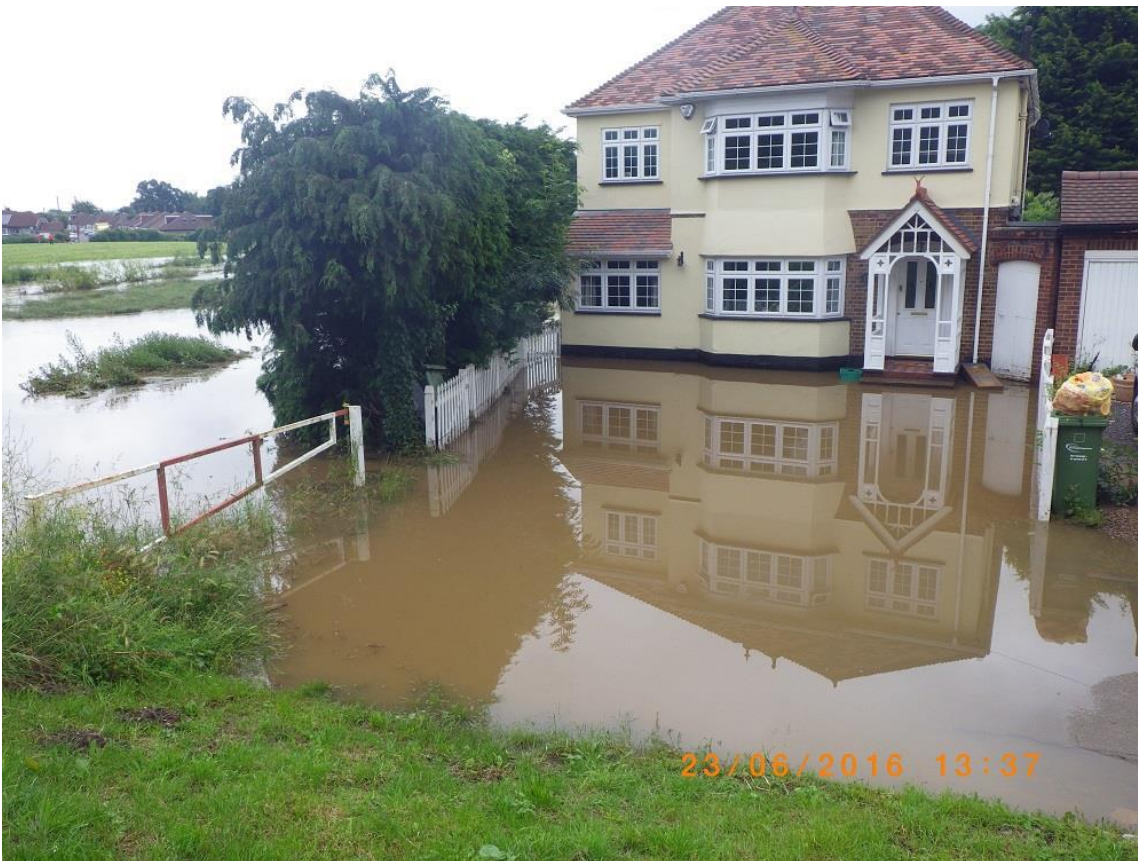
Figure 30: Flood water at Hacton Lane, looking East, 23 June 16

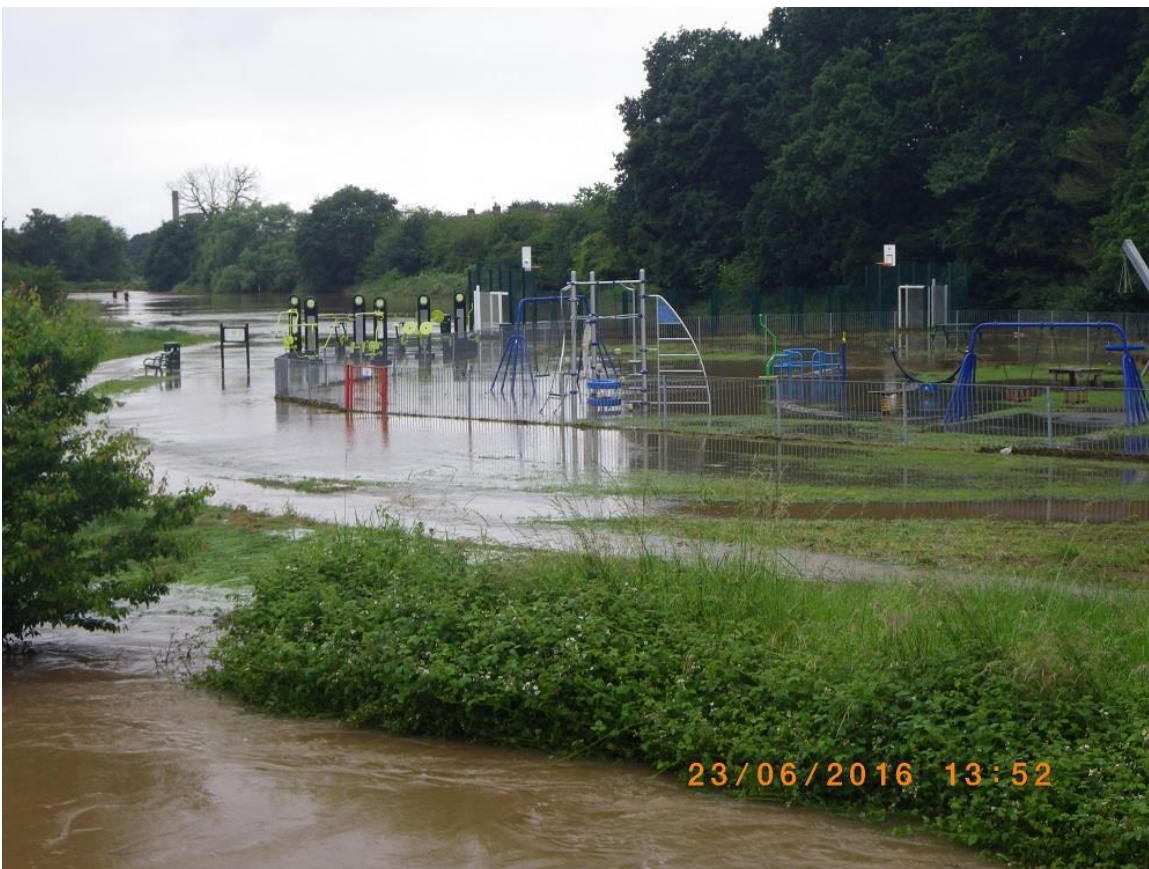
Figure 31: View of flooding in Hacton Parkway from Hacton Lane bridge looking west

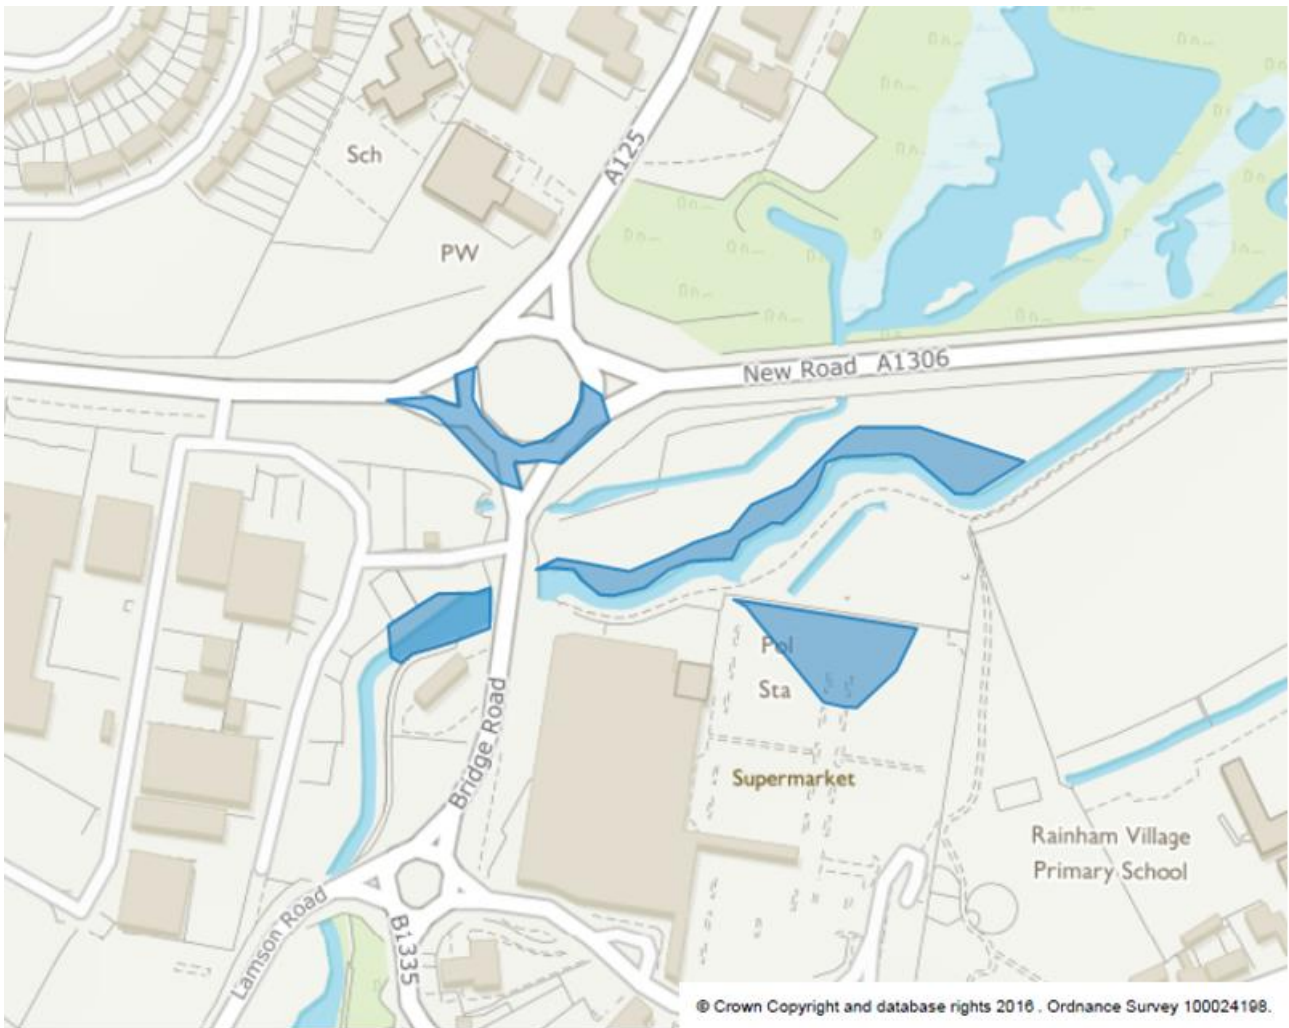
Figure 32: A map to show the extent of flooding at Dovers Corner, 23 June 16

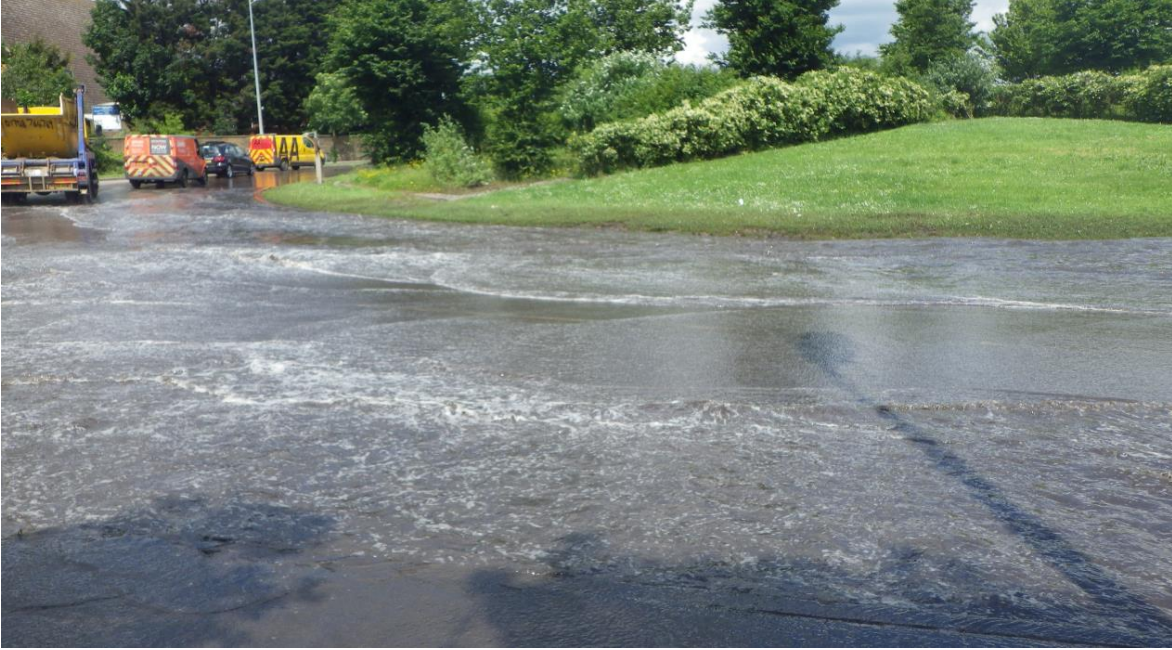
Figure 33: Photo showing flooding at Dovers corner roundabout

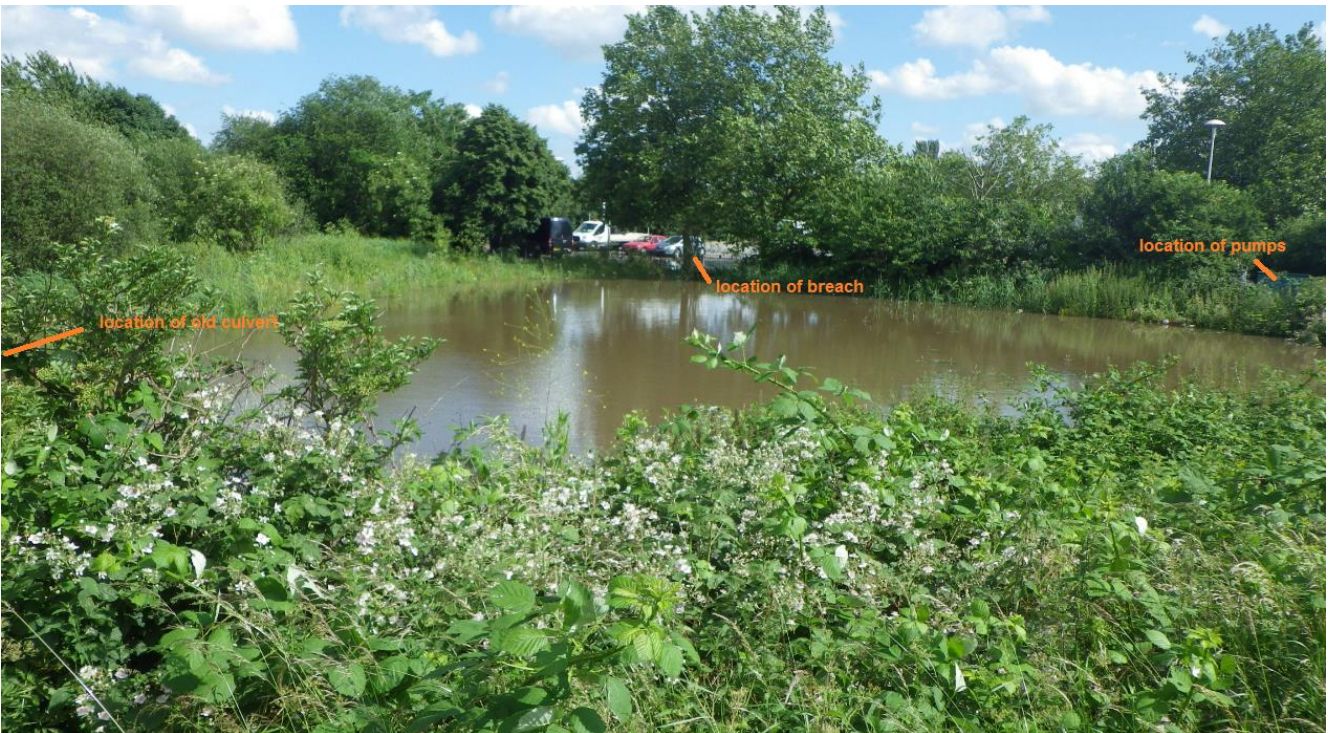
Figure 34: Photo showing Dovers Corner Flood Storage Area, 23 June 16
