Flood Investigation Section 19 Report

BL000021/RP/01 | 02

01 November 2021

London Borough of Havering

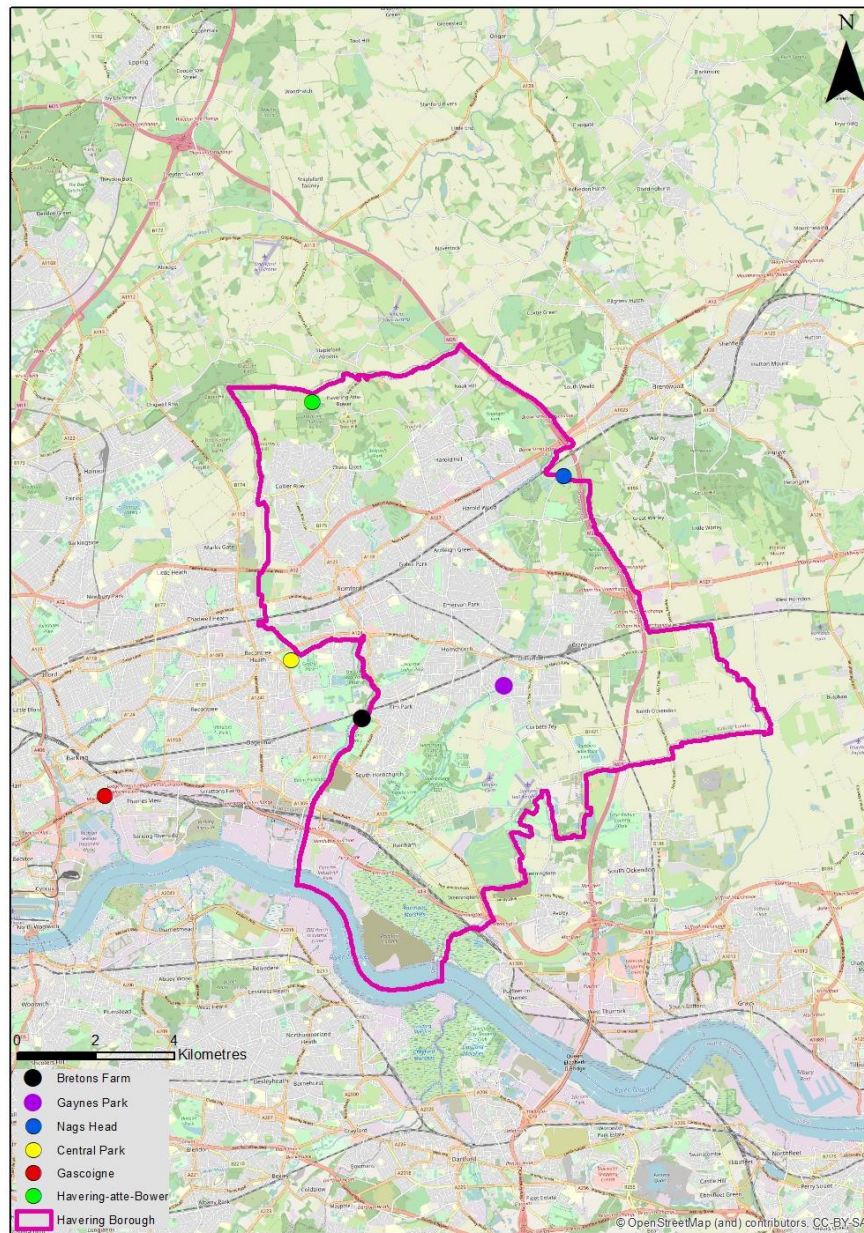
Figure 2:1 Location of Environment Agency rainfall gauges across and near to London Borough of Havering.

- the closest rain gauge (Central Park) was faulty at the time of the August 2020 event and therefore there was no rainfall data available from this location;
- the rain gauge at Nags Head was partially blocked at the time of the August 2020 event and therefore the data from this gauge was not suitable for use in the hydrological analysis; and
- due to the localised nature of the rainfall showers, the rain gauges may not have recorded all the rainfall that actually resulted in flooding.

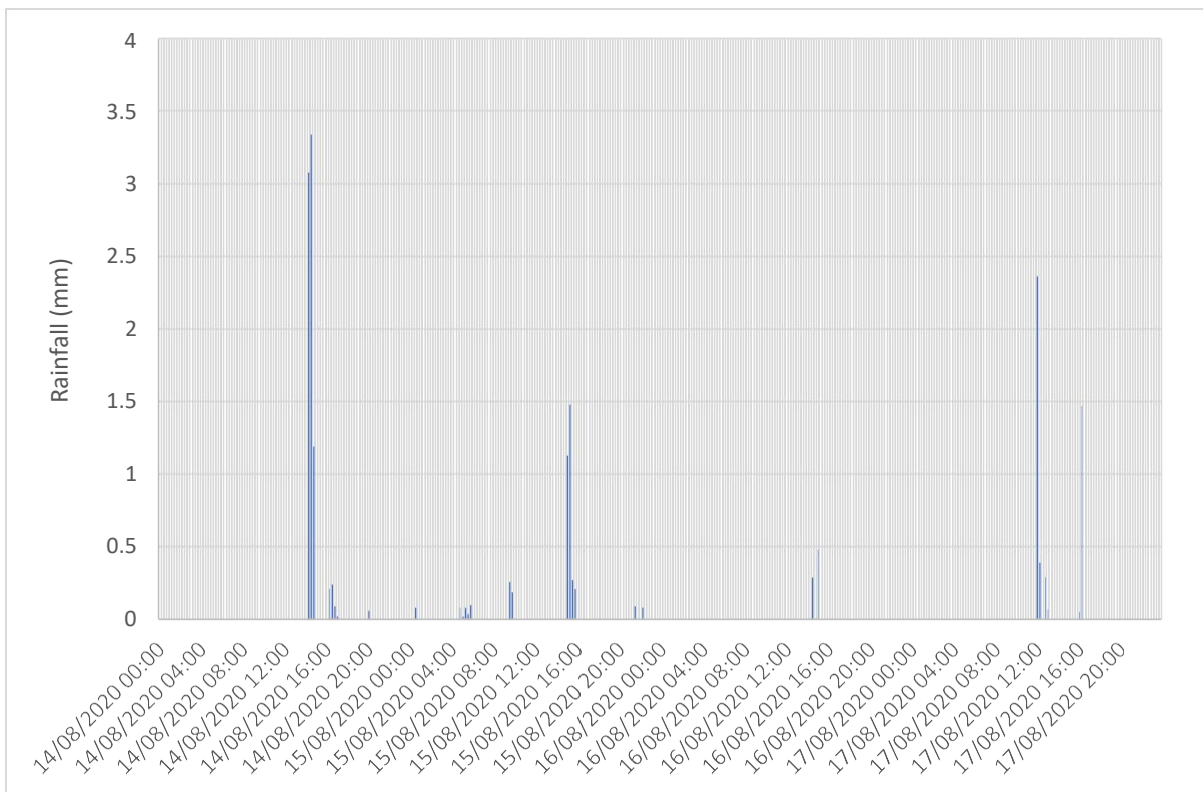
Figure 3 Recorded rainfall for the Gascoigne rain gauge over the 14th to 18th August

Radar data shows that the area around the Gascoigne Road rainfall gauge received between 8 and 16mm of rainfall over a 36-hour period. The gauge data shows that 17.74mm of rainfall was recorded over the 14th to 18th August 2020. With the majority of this falling over the 14th and 15th August, 12.17mm. Radar data in the vicinity of the Havering shows totals of up to 64mm. The Havering-atte-Bower gauge recorded 62.27mm of rainfall from the 14th to 18th August with the majority falling over the 15th and 16th August in 2 events. One where 34.31mm fell over a 24-hour period on the 15th and 16th August. A second event later on the 16th recorded 21.99mm of rainfall. On the 15th August rainfall peaked twice. The first peak was recorded at 8.5mm, which fell during a 1 hour 15-minute period where the total rainfall was 10.36mm. The second peak was recorded at 7.63mm during an event of 2 hours where 19.95mm of rain fell. Over the 15th and 16th during a 36 hour period 56.3 mm of rainfall was recorded at the Havering-atte-Bower gauge which is over half of what the Thames region recorded for the whole month of August in 2020, which was 96mm (Figures 3 and 4). The differences in the Gascoigne Road recorded rainfall and the Havering-atte-Bower recorded rainfall shows that the rainfall over the period of study was not consistent and fell in localised events. This could explain why flooding was seen in certain parts of the catchment.

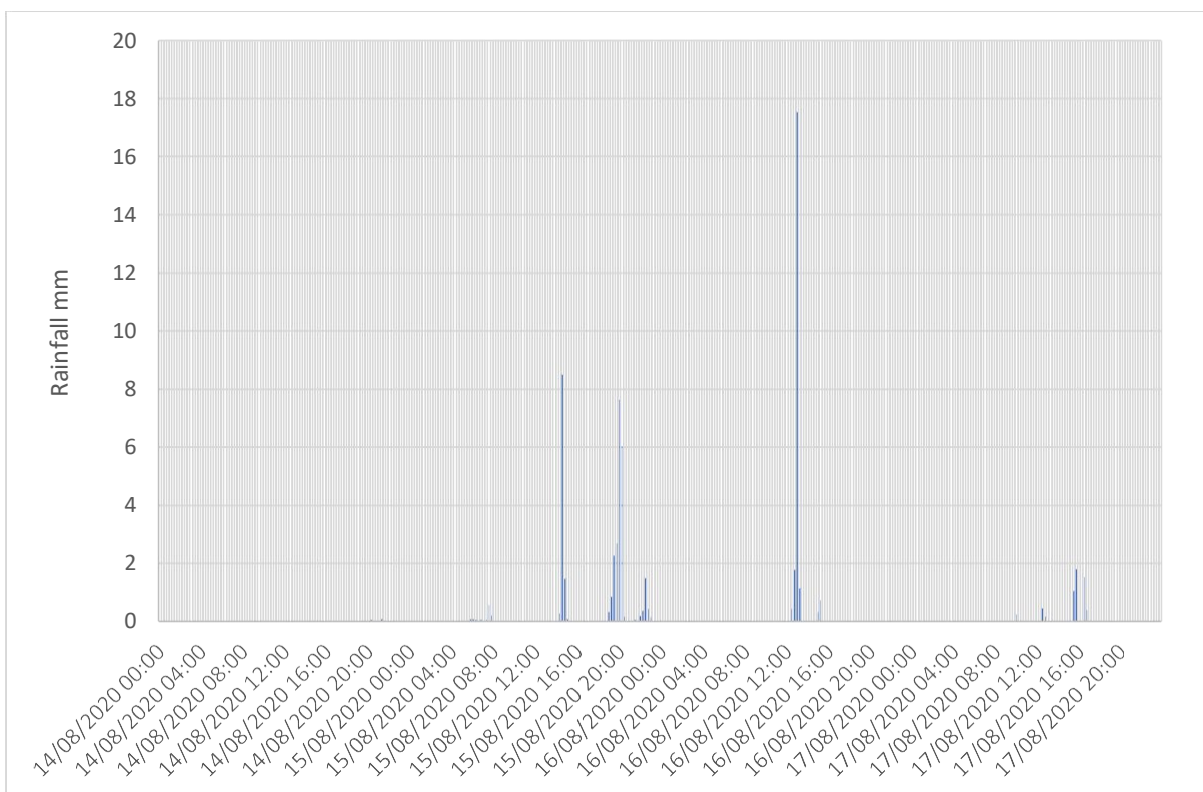
Figure 4 Recorded rainfall for the Havering rain gauge over the 14th to 18th August

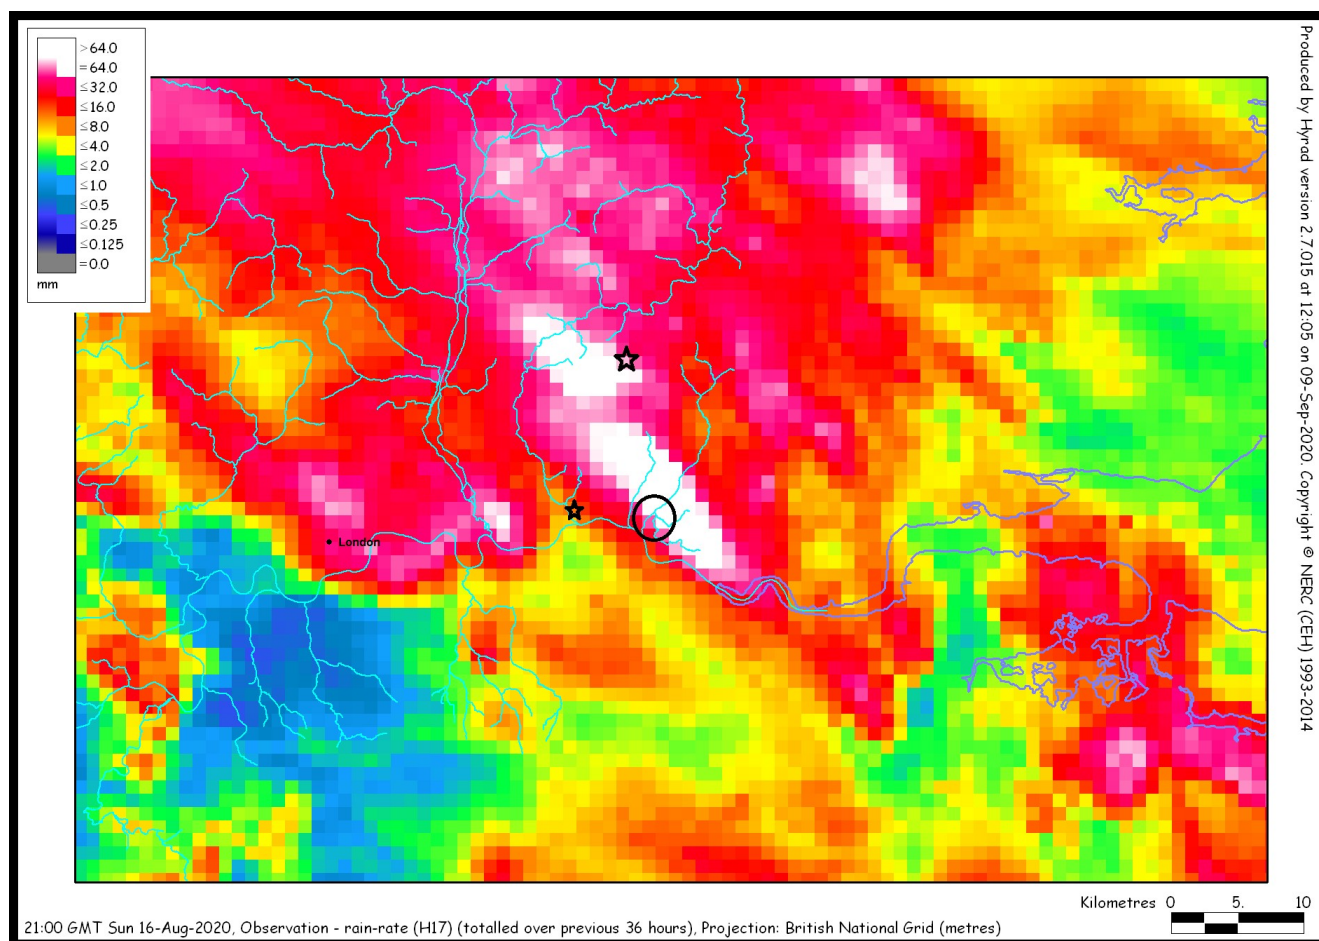
Figure 5 Radar, 36 hour accumulation at 21:00 on the 16th August 2020 showing location of rain gauges.

Radar rainfall data can be seen in Figure 5. It shows the accumulated rainfall over a 36-hour period up to 21:00pm on the 16th August. Figure 7 also shows the approximate locations of the rain gauges used to record the rainfall data. The highest intensity part of the rainfall tracked from the East and North East towards the West and South West. This means that the Havering gauge which recorded the highest amount of rainfall over the period would have recorded the rainfall before the other gauge at Gascoigne. The gauge at Gascoigne was outside the area of most intense rainfall for most of the duration.
